Technical Report

Status of Used Lead Acid Battery Management in Kingdom of Cambodia

Prepared by Project Team
Department of Environmental Pollution Control
Ministry of Environment

Phnom Penh, 2004

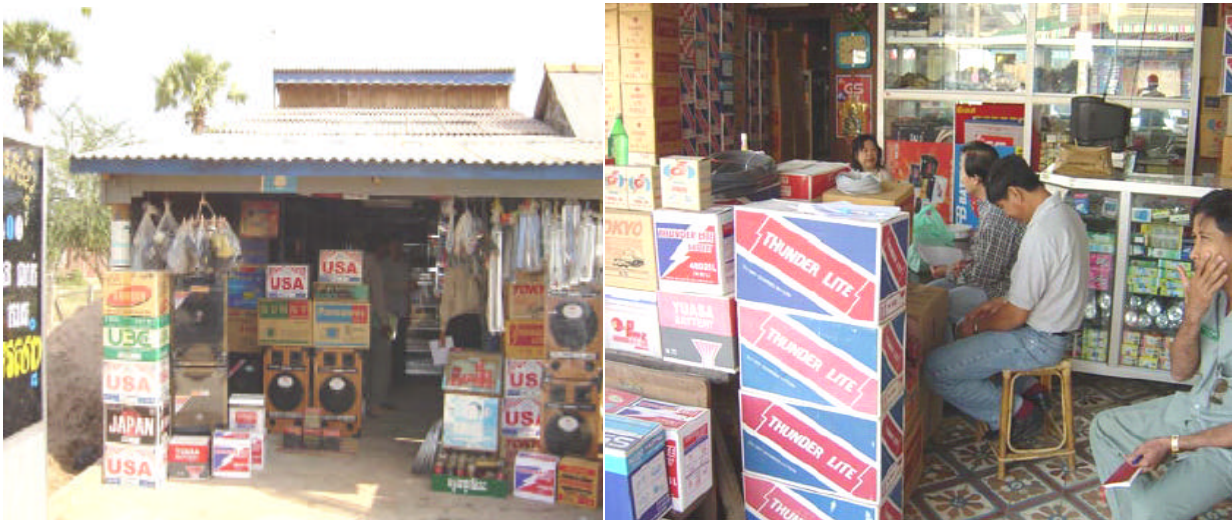
Picture 2: Typical view of a battery shop in a remote and a downtown area

25 small automotive battery retail outlets were visited in the remote and downtown areas of Battambang Province, Svay Rieng Province, Sihanouk Ville and Phnom Penh. Generally, shops are selling new lead acid batteries for trucks, cars, motor cycles and domestic use (burglar alarms, back up systems, and so on).

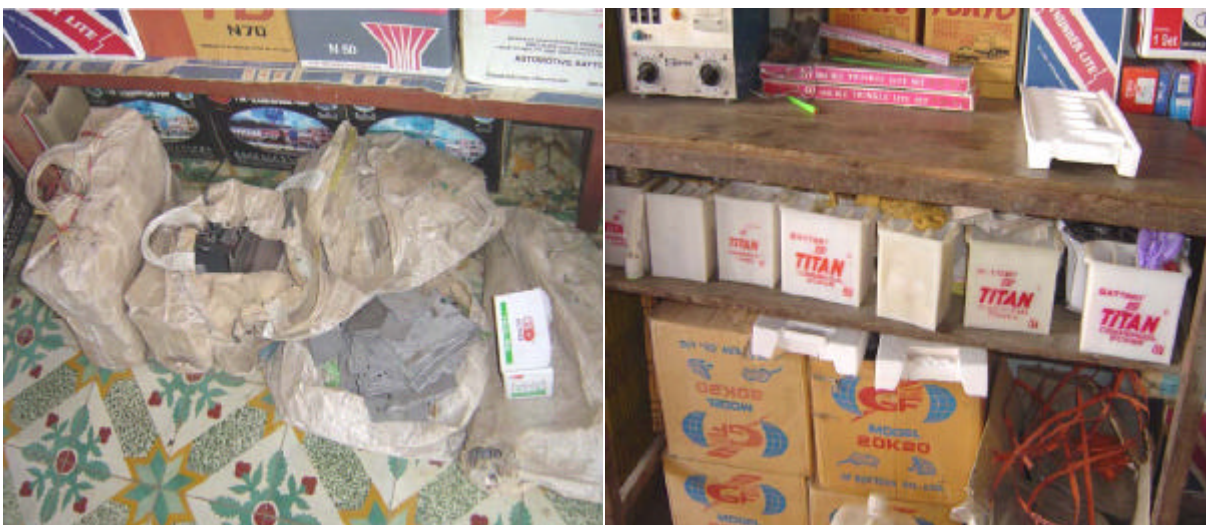
Picture 3: Lead plates and battery boxes for new LAB

Each shop had a stock of 100 to 400 new and boxed lead acid batteries imported from Vietnam, Japan, Korea and Thailand. Some battery components are made by local people in Cambodia and these can be seen in picture No. 2. All the batteries on sale were good quality and branded names. The majority of the batteries appeared to be made with the latest maintenance free (MF) technology using lead/calcium alloys grids. Sales varied, but on average, the shops would expect to sell from 10 to 20 batteries per day in the downtown areas and 1- 5 in the remote areas of the provinces.

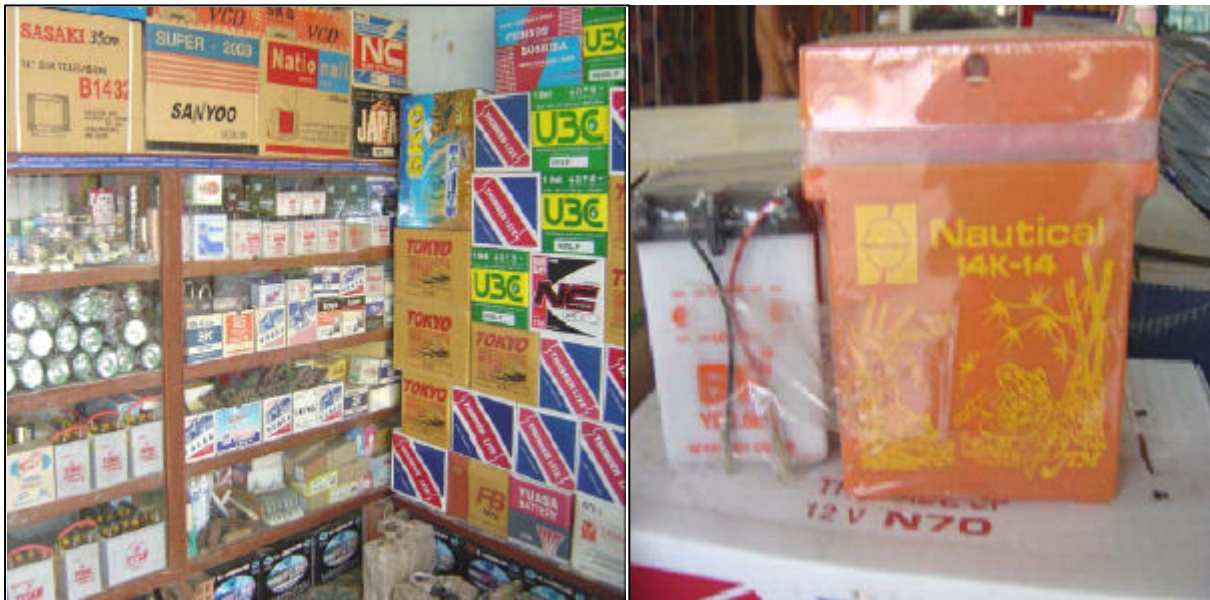
Picture 4: Battery spares and the acid used for topping up a new battery

Generally, shops did not take in ULAB in exchange for new battery sales and the customer was expected to take the ULAB with him or her when they left the shop. In the event that a ULAB was left on the premises, it would be removed by one of the many scavengers. At present, ULAB are not returned to sales outlets because there is no incentive for the buyer and there is limited storage place at the shops.

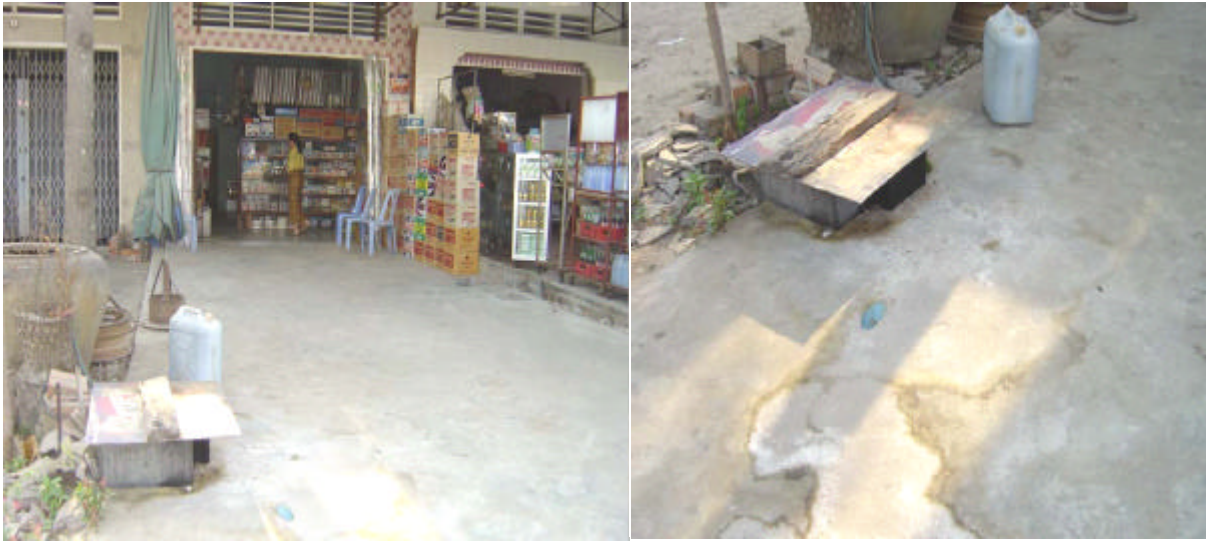
Picture 5: The battery acid is allowed to run into the public drainage system

It was the downtown retail shops with battery charging units that seemed to have the most acid spillage and caused bad smells as gases generated during charging escaped to atmosphere. The small bunded area designed to place the batteries when being serviced were contaminated by damaged batteries, but the premises were generally clean and tidy. It was clear that any acid spillage had been washed directly to the public drainage and sanitation system or allowed to percolate into the groundwater and channeled into the canal without any treatment contaminating the water (see picture 5).

Problems had been identified in the battery retail shops and improvements need to be made in order to prevent the damage to human health and the environment caused by ULAB. The recommendations are:

- ✚ Most of the staff, including the owner of the retailing shop has a lack of knowledge of the potential problems caused by the battery acid and the threat posed by lead to human health and the environment. Therefore, in the short term a training course on the safe handling and management of ULAB, including the risks of adverse health effects could help them prevent health problems and environmental damage.

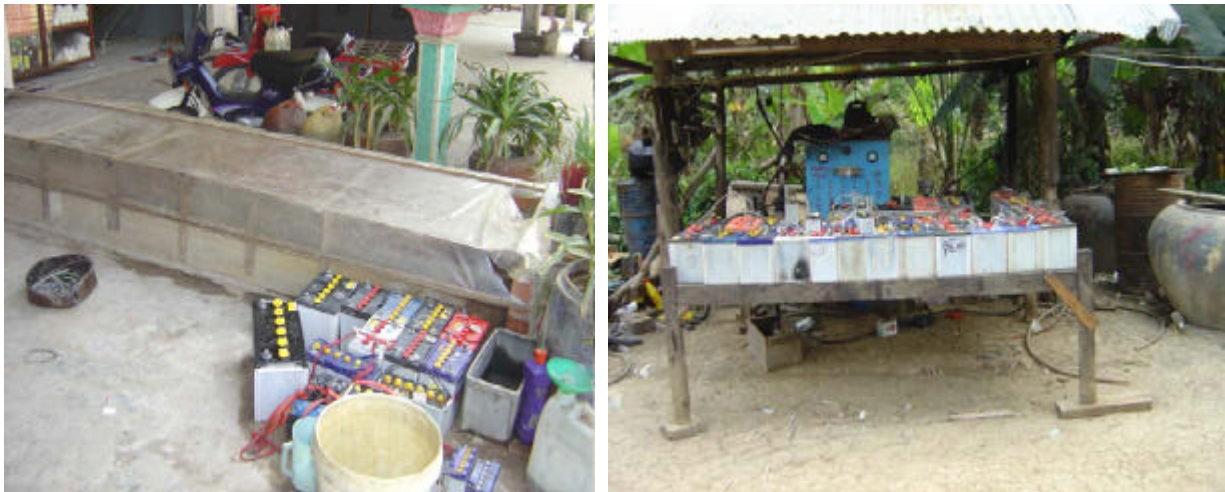
Picture 6: Typical a battery recharging shops in the downtown and remote areas

30 battery recharging shops located in remote and downtown areas of Battambang Province, Svay Rieng Province, Sihanoukville and Phnom Penh were visited during the survey. These shops were engaged in servicing and reconditioning batteries and collecting ULAB for resale to the waste recyclers.

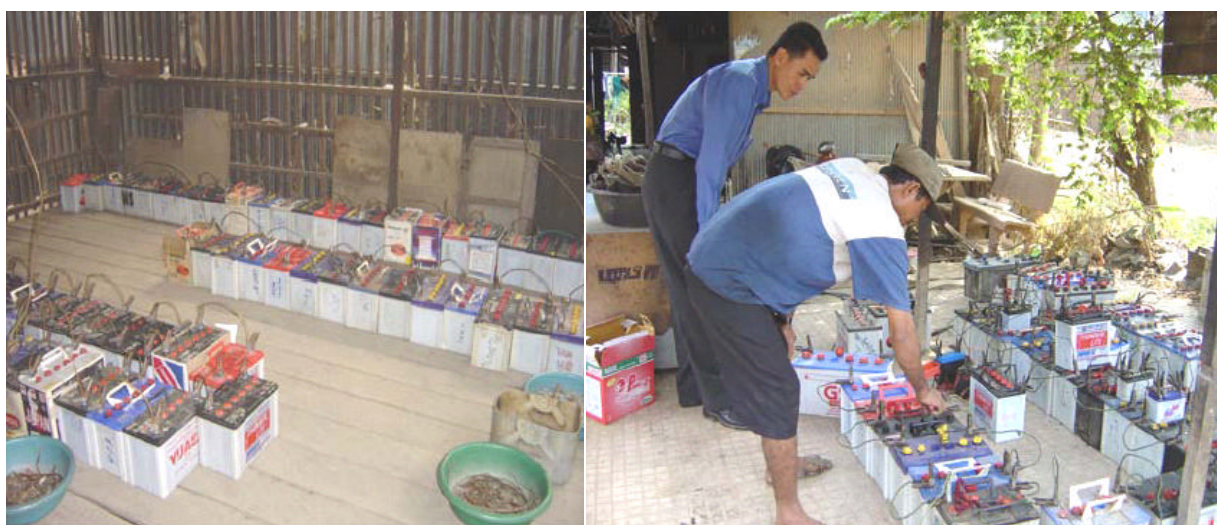
Picture 7: Batteries are charged in series

Forty to one hundred 12 volt automotive batteries are charged in series daily in the remote areas (see picture 7). Usually, a diesel generator is used to produce a DC current to recharge the batteries, especially in the remote areas, and this takes about 5 to 8 hours depending on number of batteries to recharge, the types and sizes. Normally battery acid consumption, to top up the electrolyte, is about 10 to 60 liters per month. Once recharged, a battery should normally last for 3 days, sometimes 5 days depending on the recharging technique, the demand on the battery, and the battery's age and quality.

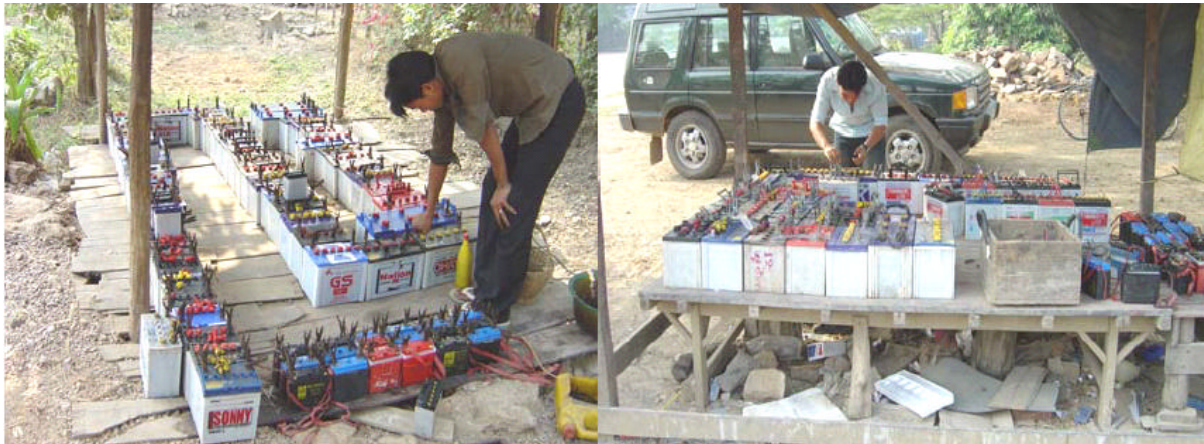
Picture 8: The battery acid is easily spilled onto the ground

In the remote areas, the recharging shop areas were mostly under a thatched or zinc roof and open on all four sides, although some premises were under cover, especially those that doubled as the family home where everyone eat together and the children played in and around the charging zone. The floor was the natural soil or wooden decking which allowed the acid to spill easily onto the ground through the gaps and holes between the slats. (See picture 8)

- ✚ A training course on the Safe Battery Recharging Procedures and Sound Management of ULAB would minimize the suffering caused to workers by poor manual handling of the ULAB throughout the country.
- ✚ The dissemination of information to the public about ULAB hazards through media such as TV, Radio and newspapers would help them to understand the health and environmental risks and initiate actions to preventing the adverse effects caused by poor management of ULAB.

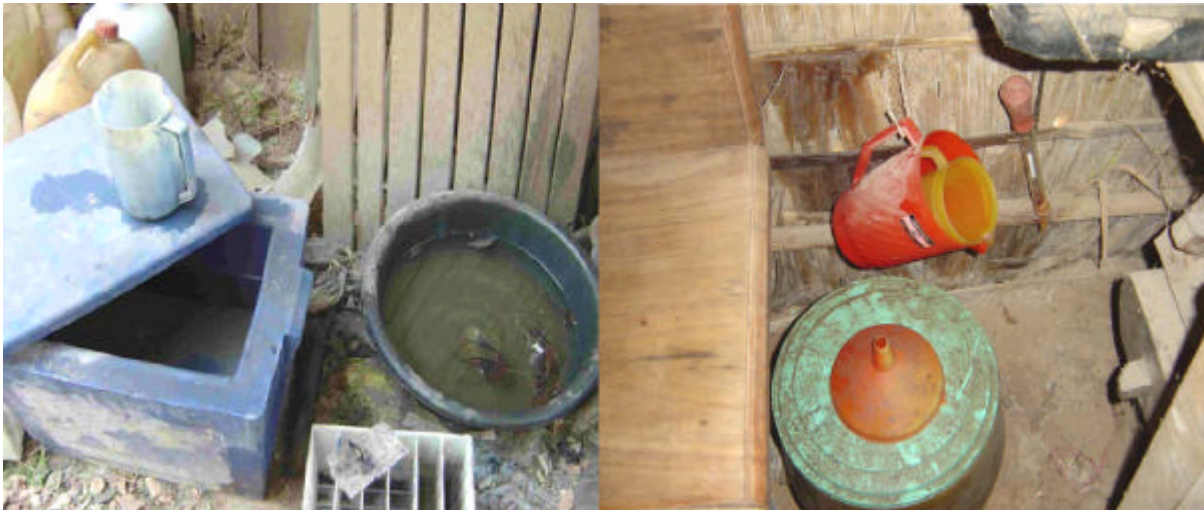
Picture 9: Battery acid in containers and drums under a bed inside the house for reuse

It was easy to see that the soil around the shops was contaminated by acid spillage and leaks that have occurred during the recharging processes. Some battery acid had been poured into tanks or some other suitable plastic container and stored for reuse (see picture 9), but in most cases the acid drips and leaks onto the ground and finds its way into a drainage ditch near the shops.

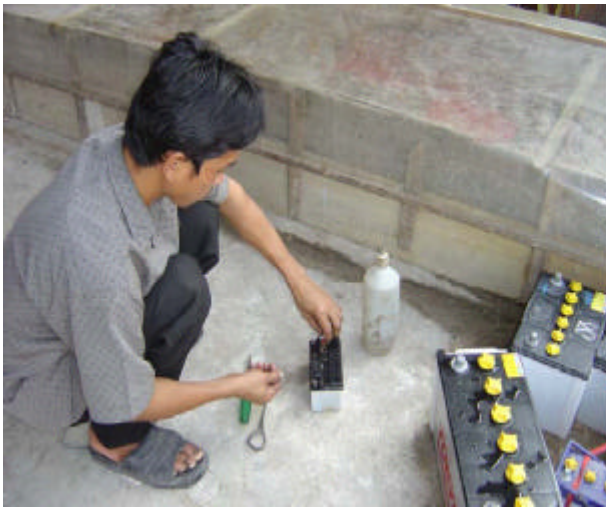
Picture 10: No gloves, goggles or mask

It is very important to wear personal protective equipment (PPE), such as gloves, goggles and masks, during the recharging process, due to the health risks posed by the safety hazards. Unfortunately, workers said that they found it inconvenient to wear PPE (see picture 10). Some workers had never worn PPE, but some just wear it when the battery acid bubbles due to a lack of understanding of personal safety (see picture 11). Interestingly, all the battery recharging workers, and some of those living close to recharging sites, recognized by themselves that there are increasing difficulties associated with skin burns and breathing problems. Furthermore, there is now a real concern among the task team because health and safety monitoring has never been carried out at battery charging and service centers.

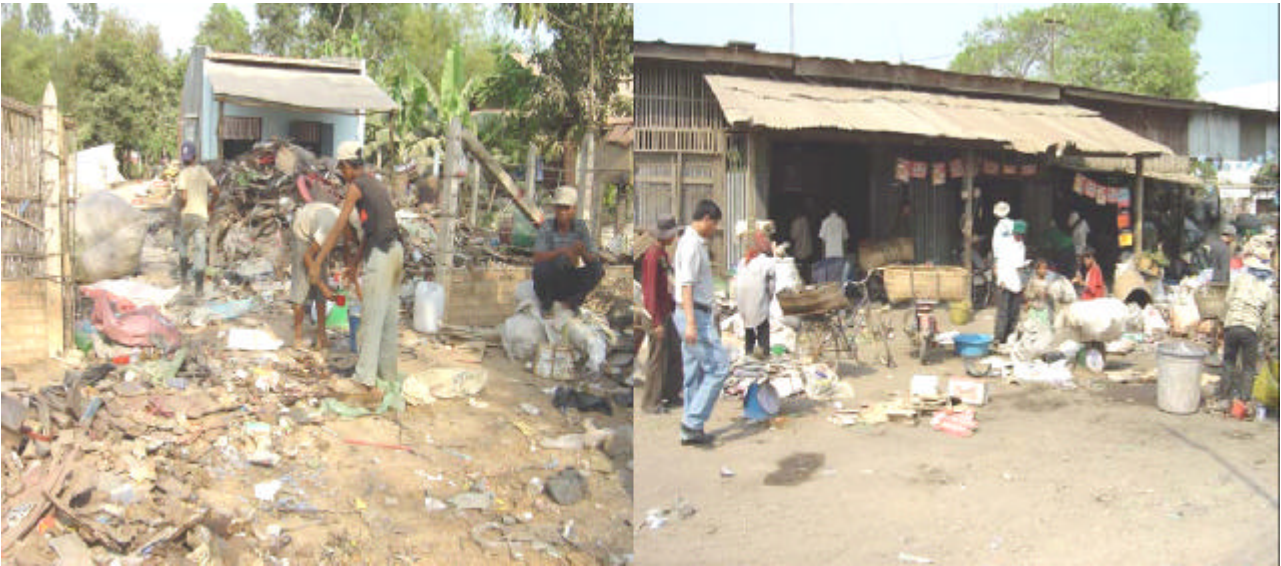
Picture 12: View of typical recyclable waste collection sites

15 of largest collection sites for recyclable wastes including ULAB were visited in the remote and downtown areas of Battambang Province, Svay Rieng Province, Sihanoukville and Phnom Penh Municipality. Most of the collection

sites were constructed on a plot with the soil as the floor or base, except for just a few sites that were constructed on paved areas.

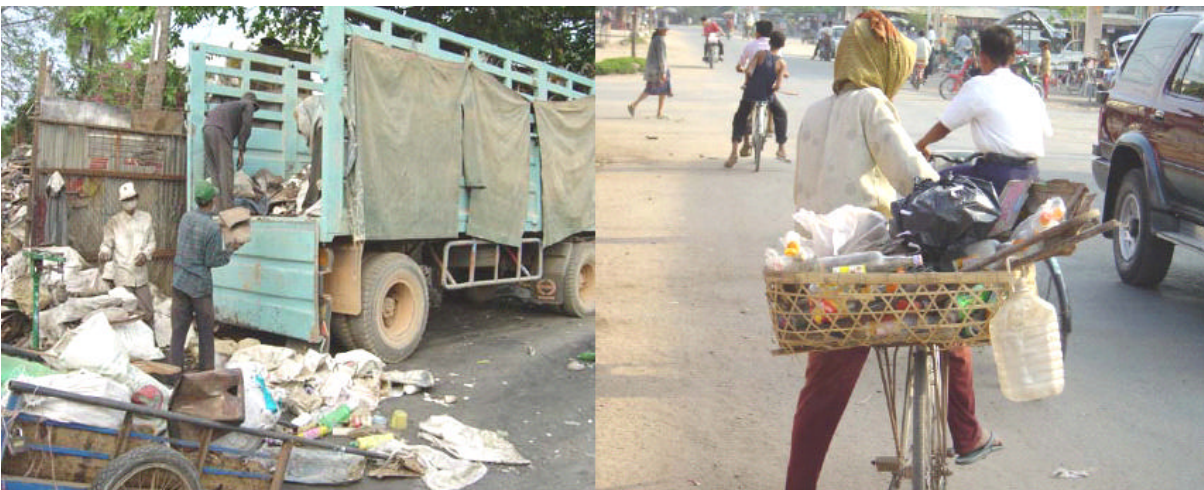
Picture 13: Vehicles and Bicycles are used to transport ULAB to the Recyclers

ULAB are collected by scavengers from small ULAB collection sites in various districts of the provinces and from local users. Usually, the scrap yard owner has his own collection network for ULAB all over the province and in many cases the neighboring province. The ULAB are transported by hand cart, bicycle, motorcycle and small truck to a recyclable waste collecting site. (See picture 13)

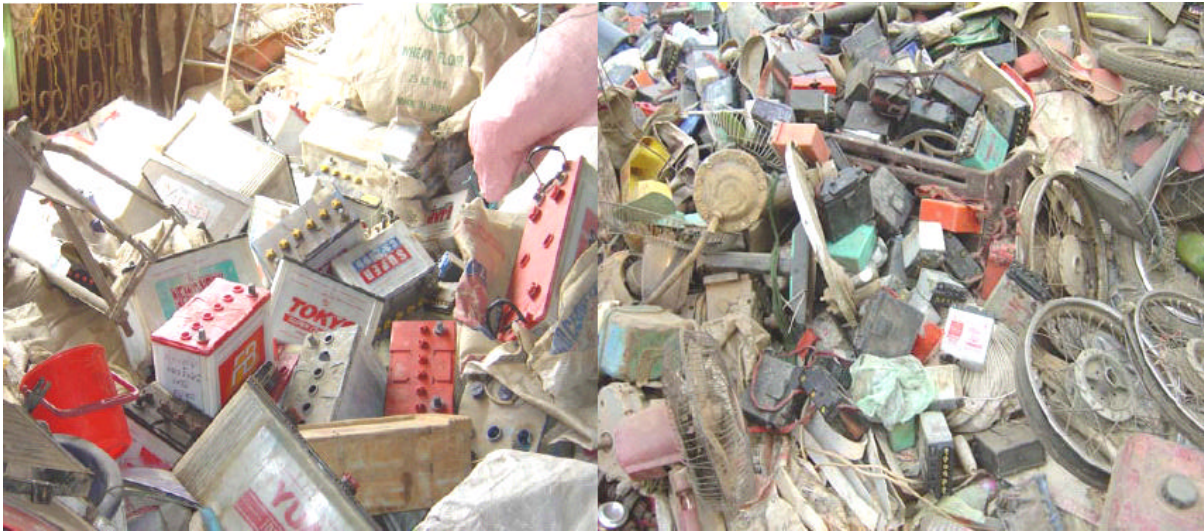
Picture 14: ULAB Secure Compound and Storeroom

All ULAB are sold to merchants in Phnom Penh and then resold to dealers abroad for recycling. Before selling the ULAB they are stored in a secure room or compound together with other piles of recyclable waste. (See picture 14)

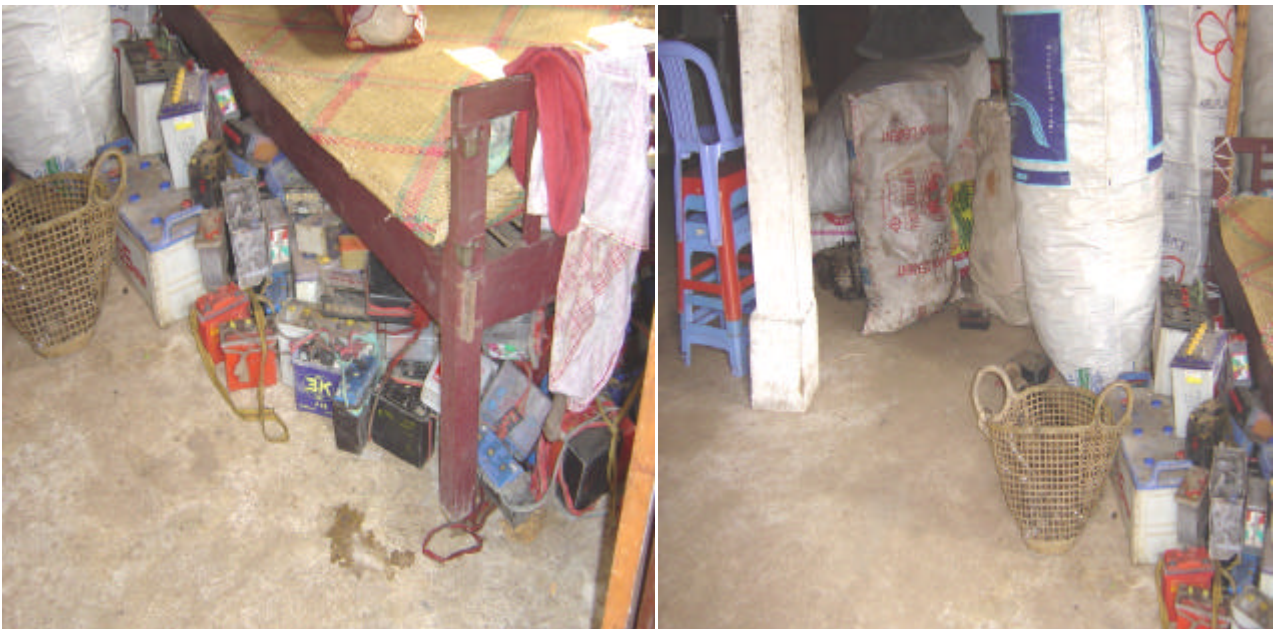
Picture 15: The ULAB are stored inside the house and in the bedroom

Generally, before selling the ULAB they are stored in a secure room or compound together with other piles of recyclable waste. Sometimes batteries were seen to be stored inside houses and on one occasion in a bedroom and under a bed. (See Picture 15).

- ✚ The careless storage of ULAB and electrolyte shows that workers, including the owners of the ULAB collection sites, are not aware of the hazards associated with the ULAB. Therefore, a training course on safety management and correct transportation procedures of ULAB would help them to minimize the risks that are posed by ULAB.

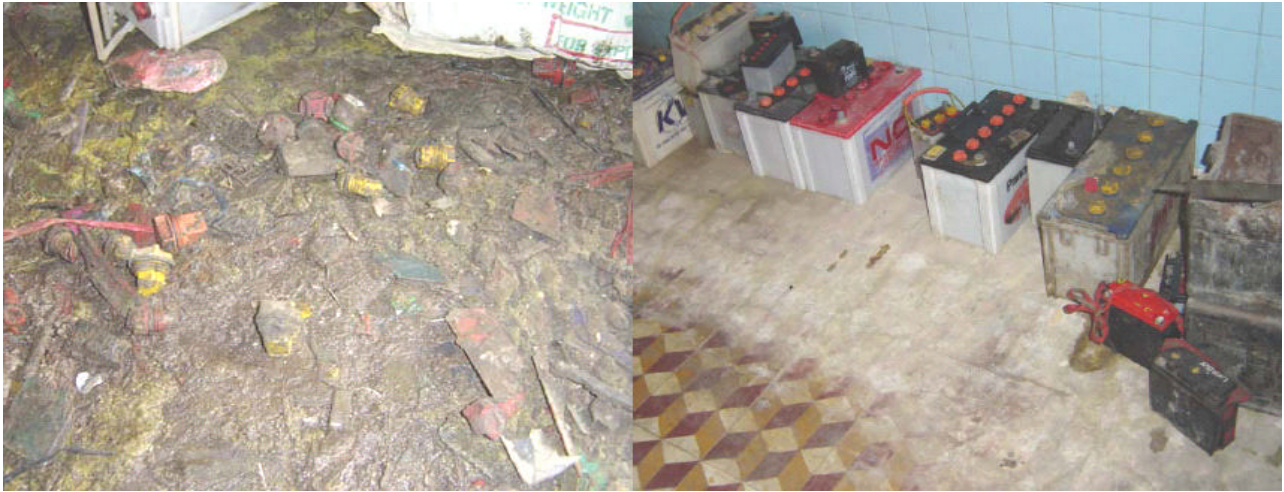
Picture 16: Acid spillage on soil and paved floor storerooms

The floor of the room or compound is just soil that could easily be contaminated by spillage of battery acid. (See picture 16).

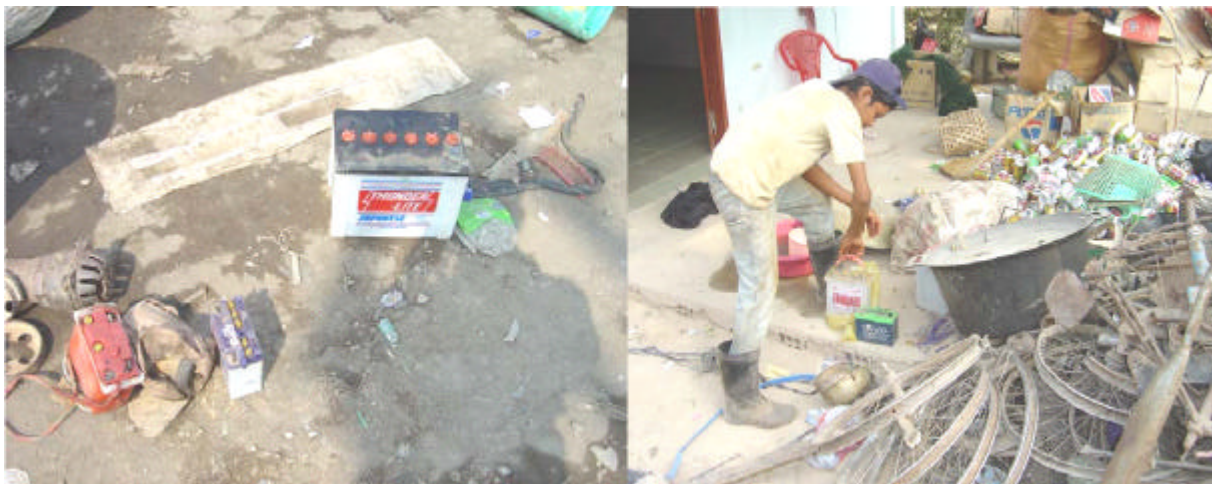
Picture 17: Battery acid drained into the ground at the collection sites

Battery acid drained directly into the ground, then found its way to a ditch and finally the public drainage and sanitation system, resulting in water contamination (see picture 17). There was no attempt to keep it in a tank or a container at the collection site. One of the most noticeable side effects of this poor practice was a bad odor in the storage room and around the premises.

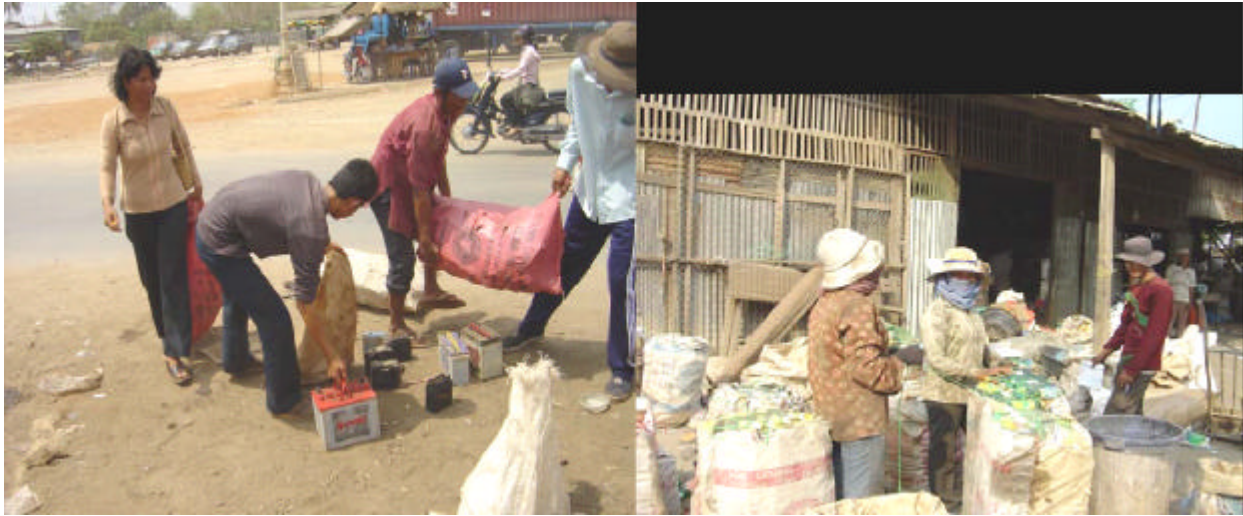
Picture 18: Some scavengers were wearing masks or gloves, but others were not

Workers were not wearing any gloves, goggles or masks when handling ULAB, except for a few scavengers and an owner who was working on other waste materials (see picture 18). Such behavior is particularly disappointing because in one case, the owner and the workers were aware of the risks of skin burns caused by the battery acid and still did not wear gloves, but no one seems to be aware of the hazards associated with occupational lead

exposure. Furthermore, the workers had never heard about any educational programs related to the management of ULAB introduced by the relevant governmental agencies or NGOs.

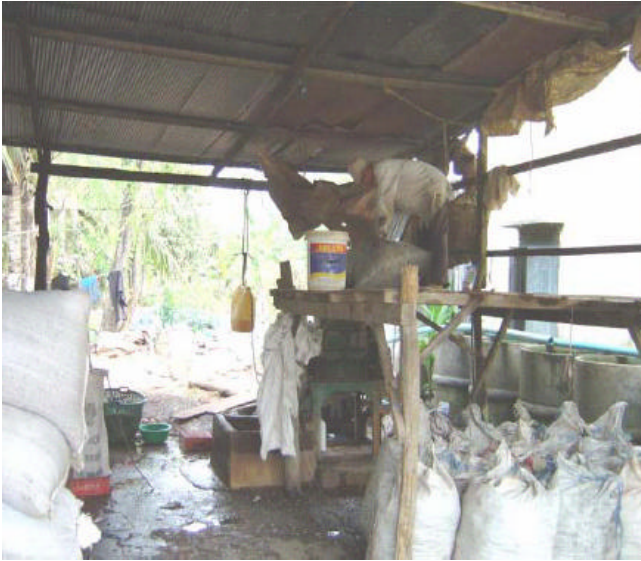
Picture 19: The plastics milling machine

Only one small scale ULAB recycling enterprise was found and visited. It is located in Thmor Koul District, Battambang Province, at the north of the country approximately 300 km from Phnom Penh and built on a plot of land. This unit has been operating since 1999. For the first three years, this enterprise only milled plastics, including ULAB cases that were bought from other scavengers, but for the last two years the enterprise has been recovering the lead from ULAB (see picture 19). All the ULAB are transported from the recyclable waste collection site to the enterprise in an open vehicle.

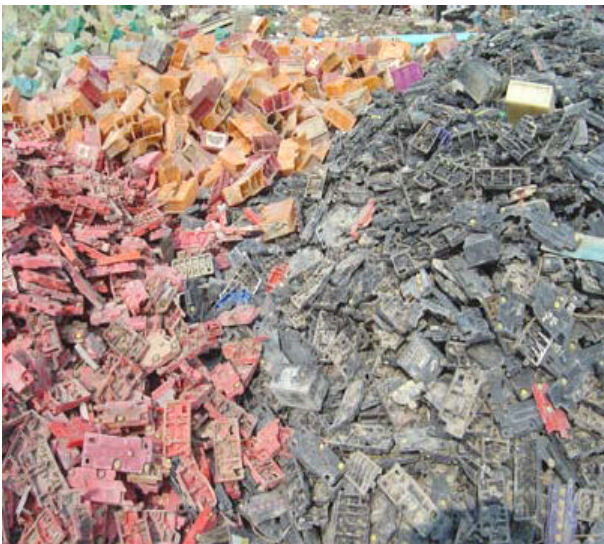
Picture 21: Battery case separation site

The red caps and the white or black battery cases are separated from the plates at another site outside the enterprise and are milled separately (see picture 21). The scrap plastic is sold in Phnom Penh and then sold on in Vietnam and sometimes, depending on the prevailing price; it has been sold directly to Thailand for recycling. The price of scrap plastic varies. White and red scrap is more expensive than black plastic scrap (see picture 22).

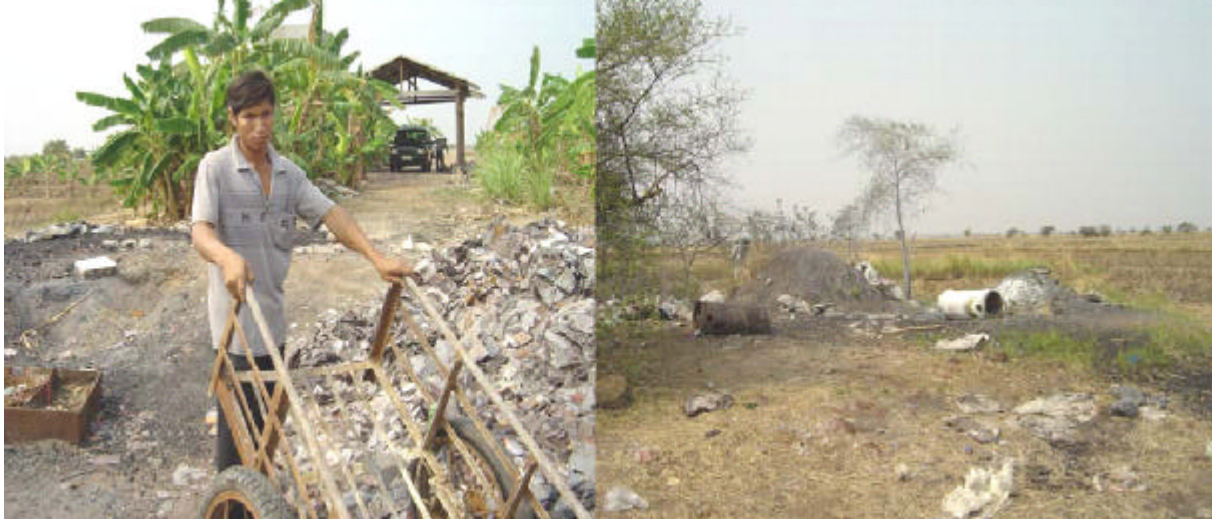
Picture 23: Views of the first and second lead melting sites

The recycling enterprise still has two separate lead smelting sites not located on the plot with the milling machine. The first one is a plot (60 x 100) surrounded by rice fields and about 8 km from the enterprise and 2 km from populated areas.

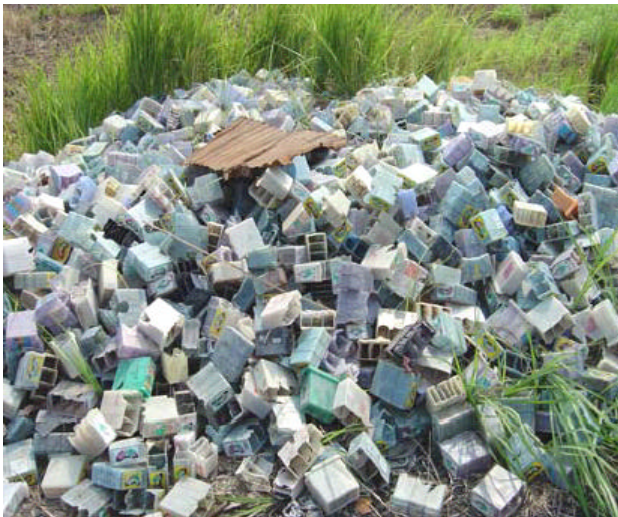
Picture 24: Battery cases after breaking

The ULAB breaking operation is manual. The lead bearing waste was placed on the ground near the smelting furnace (see picture 24). The battery cases are sent to the milling machine and the remainders, such as the plate separators, are put into a pile for incineration (see picture 25).

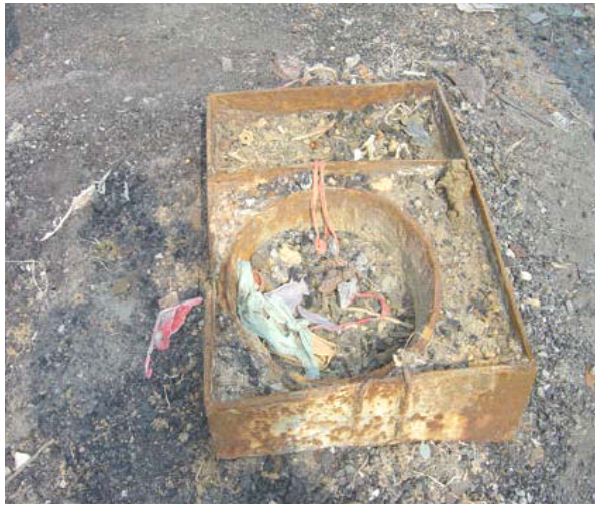
Picture 26: Crude smelting furnace

The lead bearing waste is melted in the open and without any form of ventilation or extraction using a small crude melting furnace made from a length of metal tube about 1 m long and 0.4 m in diameter (see pictures 26 and 27). Charcoal is added to the leaded scrap as it is charged to the melting furnace in order to encourage reduction of some of the battery paste (lead oxide) to produce metallic lead (lead bullion).

This technique is crude, but is the basis of “smelting” where the “reducing” agents are mixed with the leaded scrap to produce metallic lead. Adding the charcoal does raise the level of lead recovery from the scrap battery contents.

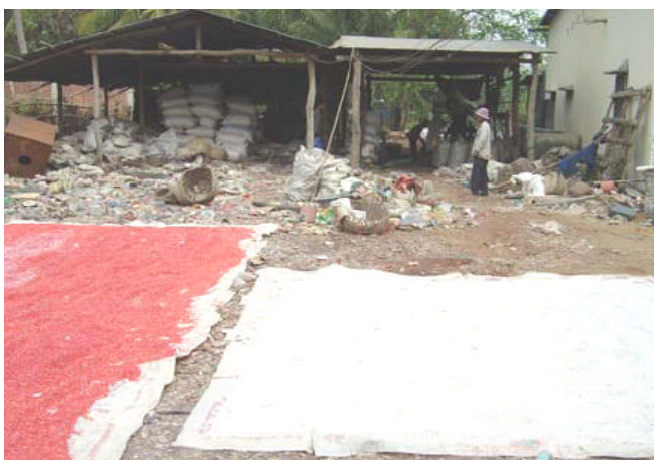
Picture 28: Bad smell at the enterprise

The environmental conditions at the enterprise and around the plot were not good due to a bad smell from the milling process and the piles of battery cases containing acid (see picture 28).

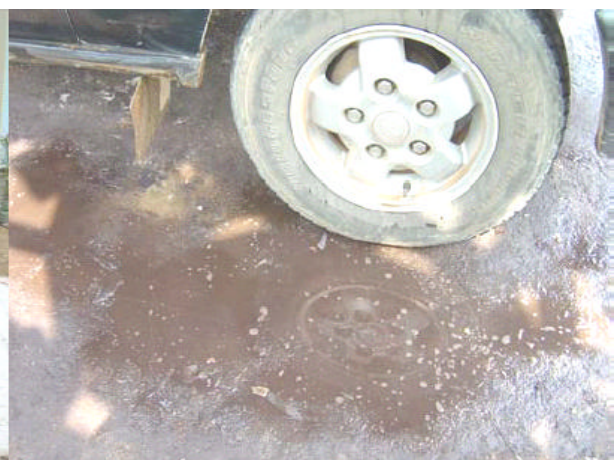
Picture 29: Contaminated soil

The breaking process area is under a corrugated zinc roofed hut open on all four sides. The floor is earth that is contaminated by spillage of the battery contents including the acid during the battery breaking process (see picture 29).

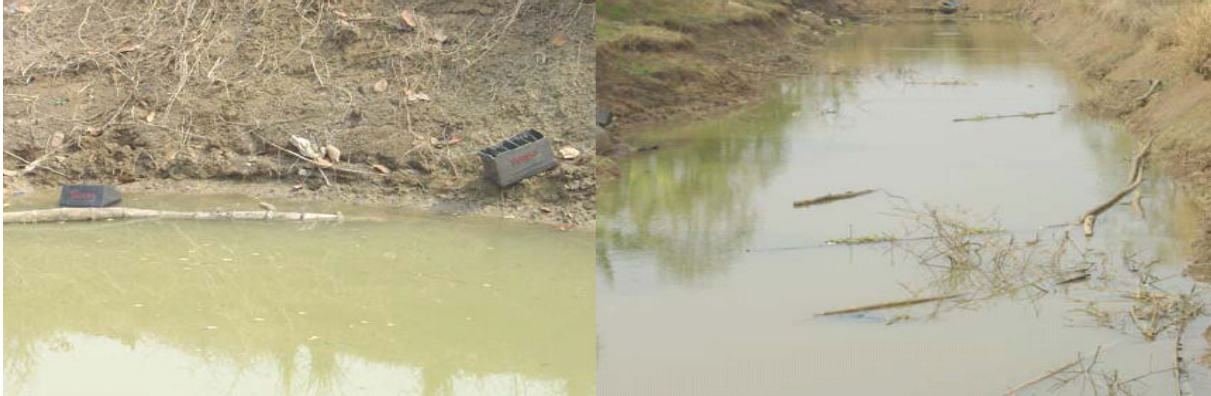
Picture 30: The two compounds near the melting furnace site

There are two big compounds close to the lead melting site with rubbish and waste burning in the open on the plot. (see picture 30). Ground and surface water either flows from the melting site into both compounds or the rice field during the rainy season. There were plenty of fish in the ponds and the fish are eaten by local people and the owner of the melter. Sometimes the water from the ponds has been drunk by the local people and used for irrigating farmland.

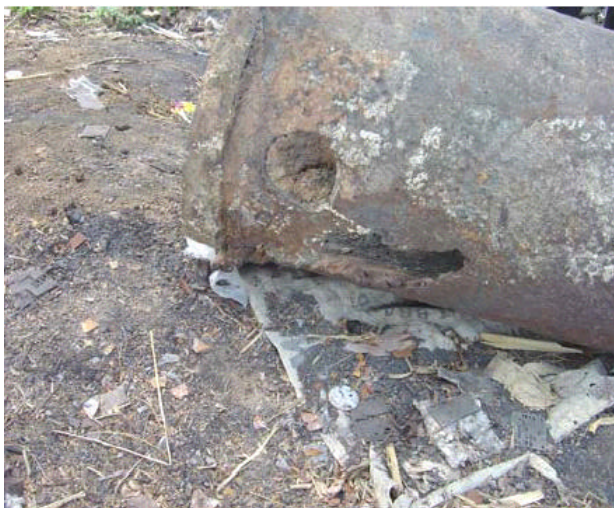
Picture 31: The corroded furnace tube

Furthermore, not only was a green tree close to the site becoming a white color and about to die, there were no wild animals present and a part of the thick metal furnace tube were also seriously corroded as pictures 31 and 32 show.

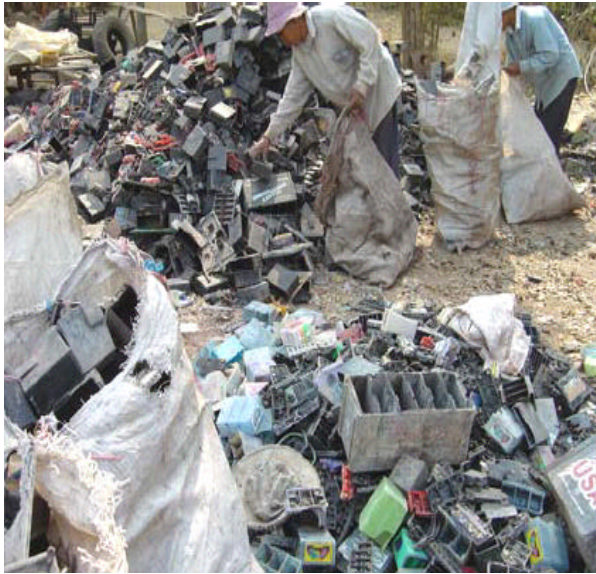
Picture 33: No gloves, goggles or mask

The workers at the sites were working without gloves, goggles or masks during the separating and milling processes, although they had been issued with both gloves and masks, but for some reason, were not wearing them (see picture 33).

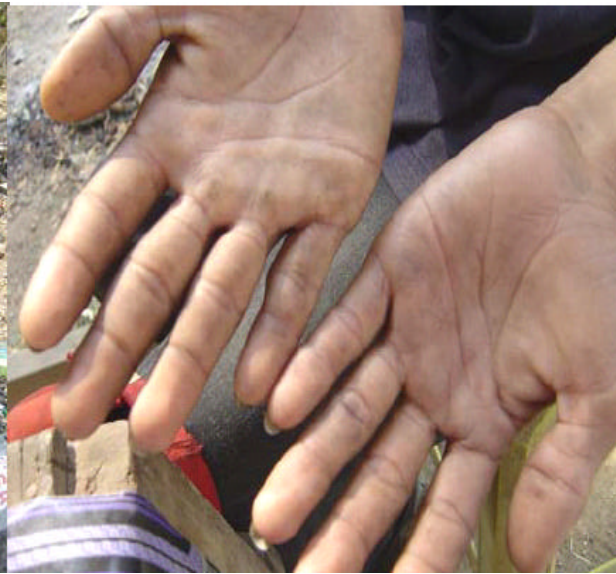
Picture 34: Palm burned by battery acid

Most of them were aware of the risks of burns to the skin caused by battery acid, but no one was aware of the hazards associated with occupational lead exposure. For instance, the ULAB breaking operation is manual and the workers were not wearing gloves, goggles or masks, resulting, not unexpectedly, in the palms of the hands visibly burned by the battery acid (see picture 34). The local people maintained they suffered from frequent headaches, found it very difficult to breath at night and there was a bad smell from the site. The workers not only suffered burns to the palms of the hands, but often had headaches, chest pains and breathing difficulties. Health monitoring, particularly blood lead monitoring is never done by the enterprise and it would appear that nobody takes responsibility for occupational health at the enterprise.

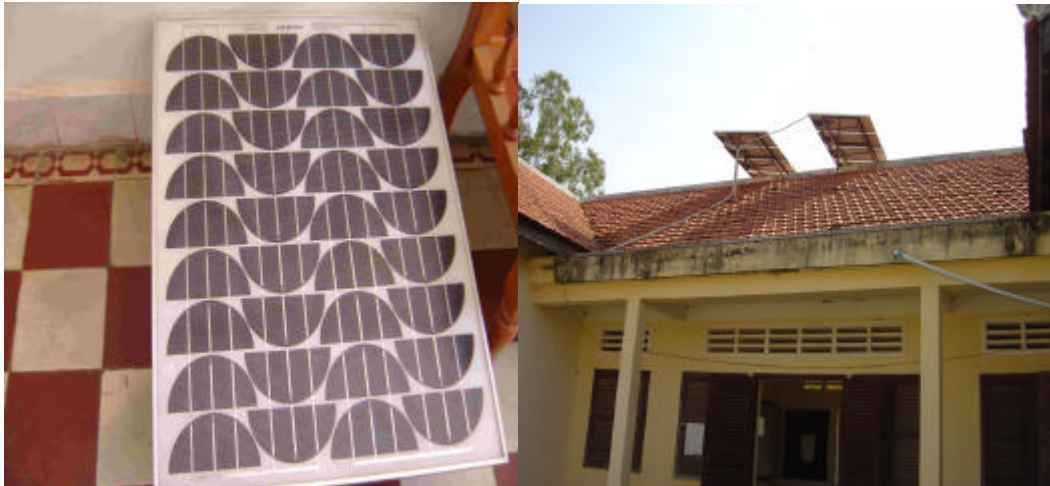
Picture 35: RAPS installed at a public school in Svay Rieng province

Solar energy Remote Area Power Supply units (RAPS) have only recently been introduced in Cambodia due to the cost of the equipment. Consequently, only a few RAPS units have been installed by local people. Mostly they have only been installed with government assistance or through international organizations or NGO aid programs at public schools, parks, municipal buildings and bridges (picture 35).

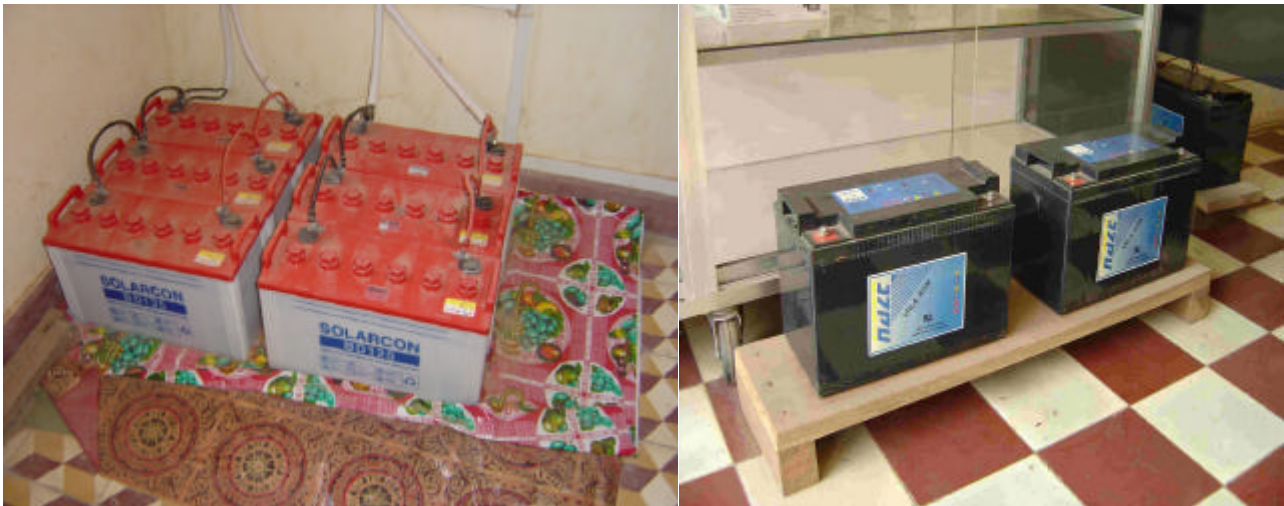
Picture 37: Battery storeroom

Normally, deep discharge lead acid batteries are stored in a secure room with ventilation controls. The floor of such a room is paved to prevent any spillage of battery acid damaging the surface or seeping into the ground (see picture 37). At the school in Svay Rieng province, it was noticeable that the storage room is clean and there was no acrid or foul smell.

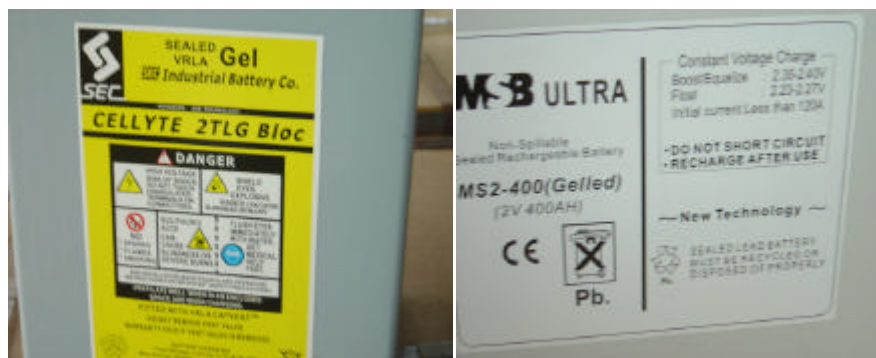
Picture 38: Valve Regulated Gelled Batteries

Noticeably, most of the batteries are branded names from Germany, Japan and Malaysia (picture 38).
