*Identification and
clean up of PCBs in
Sweden*

*Per Lilliehorn
Gunilla Bernevi Rex*

The Swedish Approach

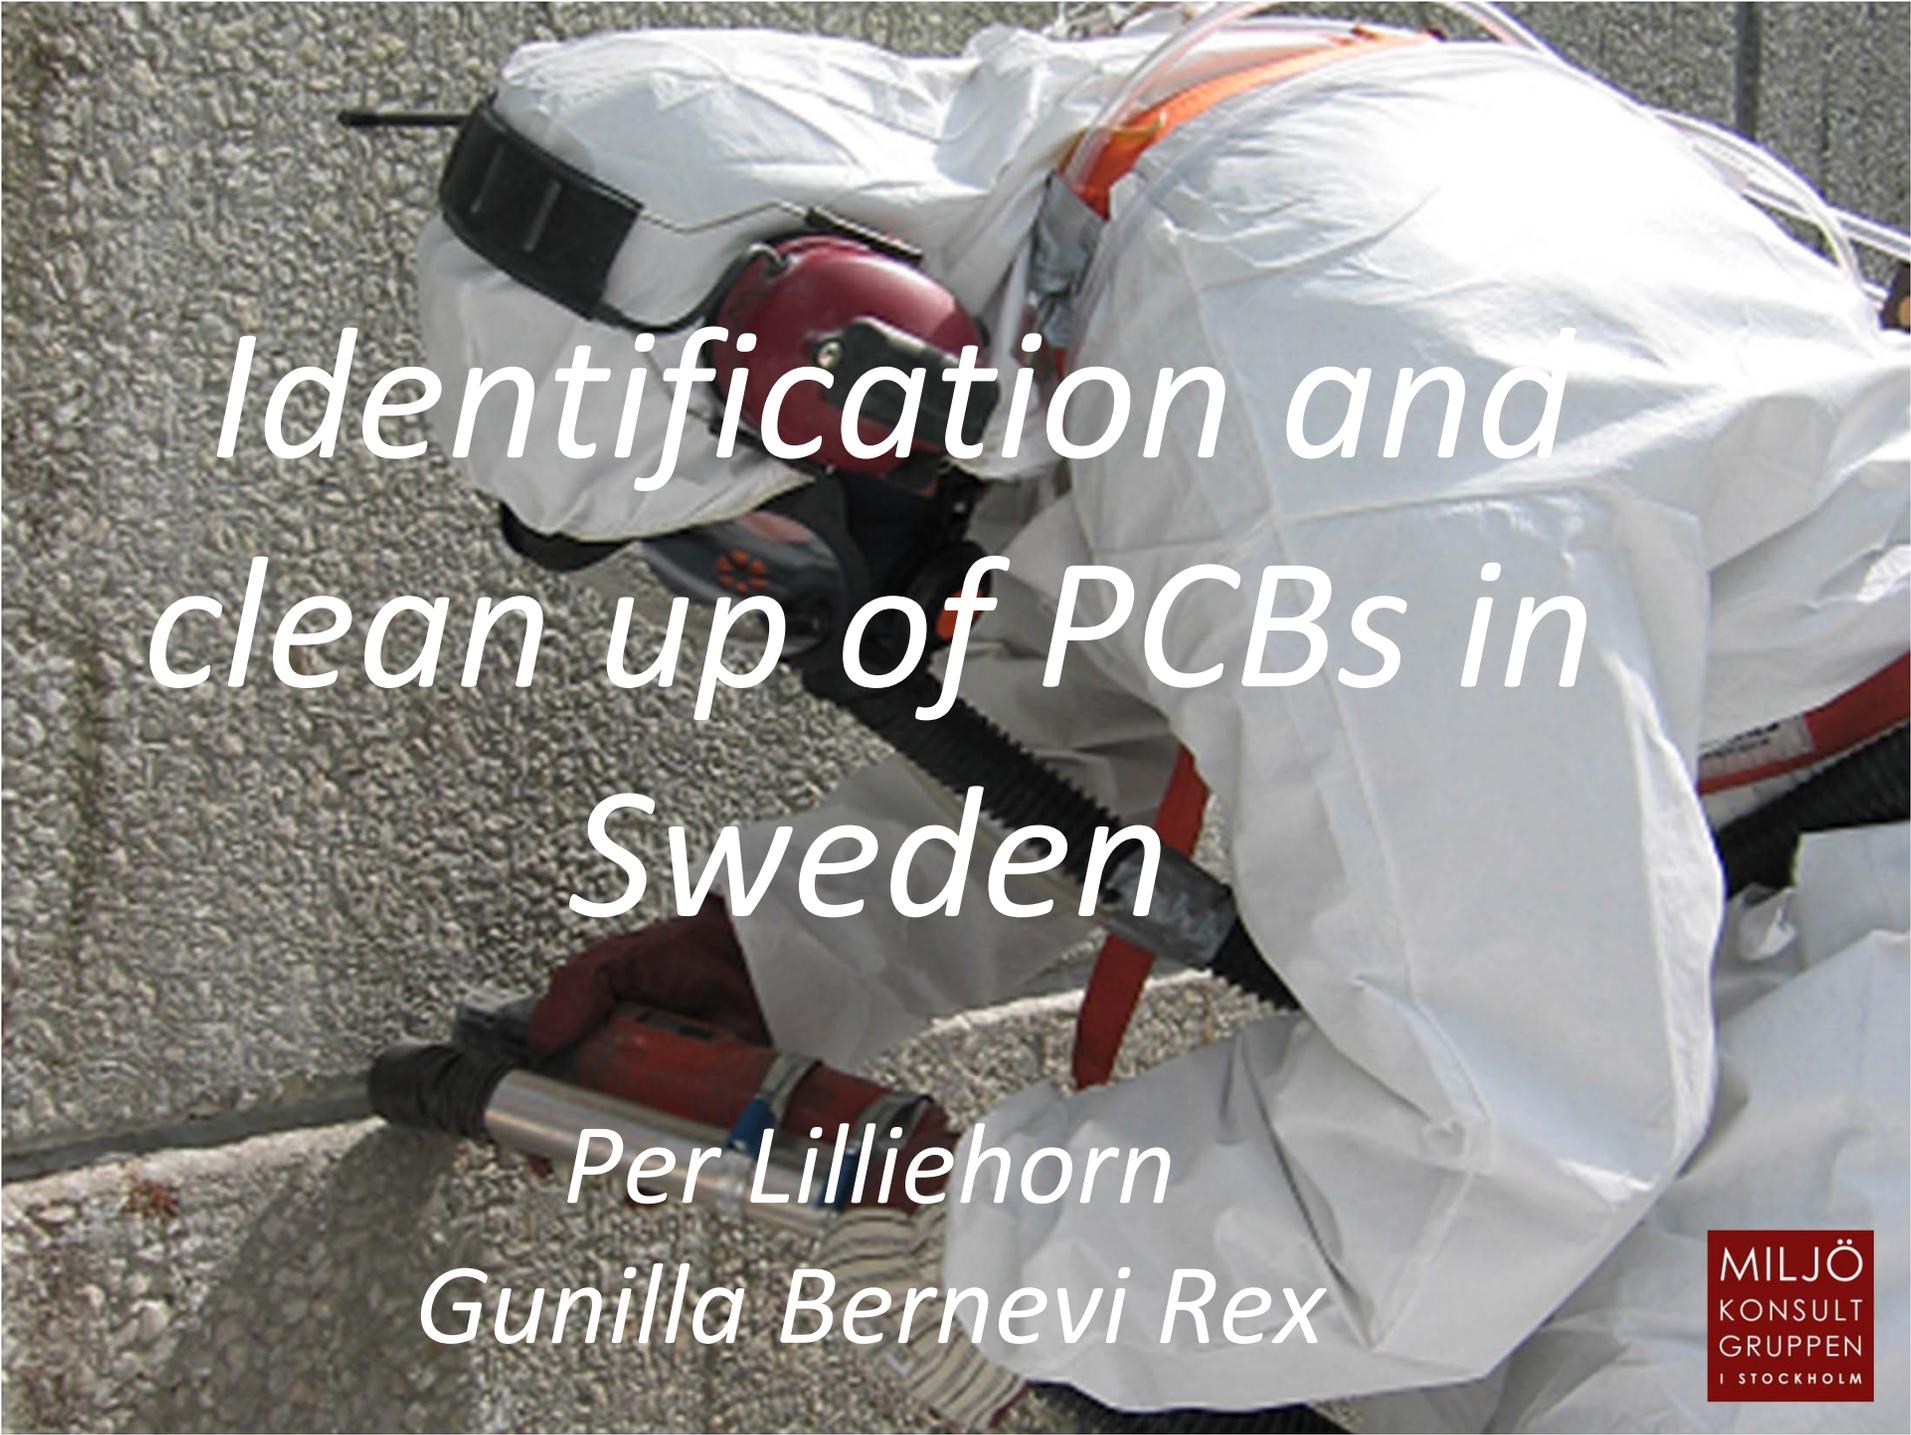
A person wearing a full-body white protective suit, a red helmet, and a black respirator mask is kneeling on a gravel surface. They are holding a red and black power tool, possibly a saw or drill, and appear to be working on a concrete curb. The background is a gravel area.

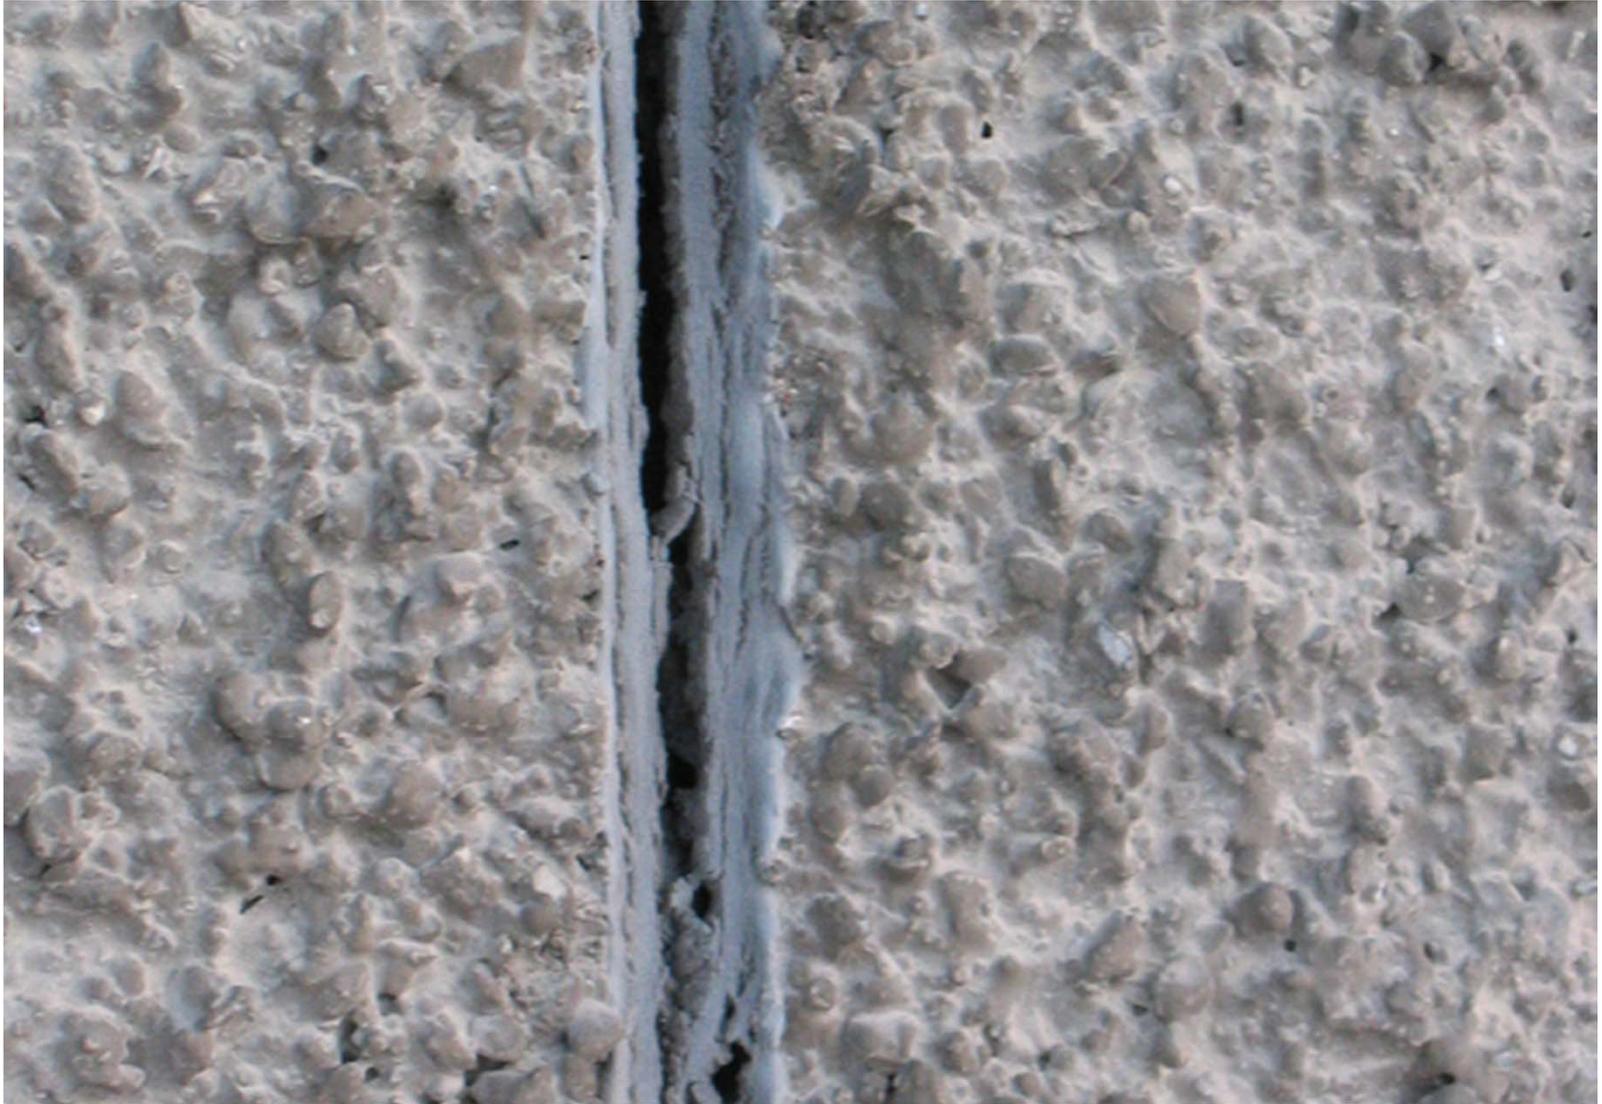
Old sealant

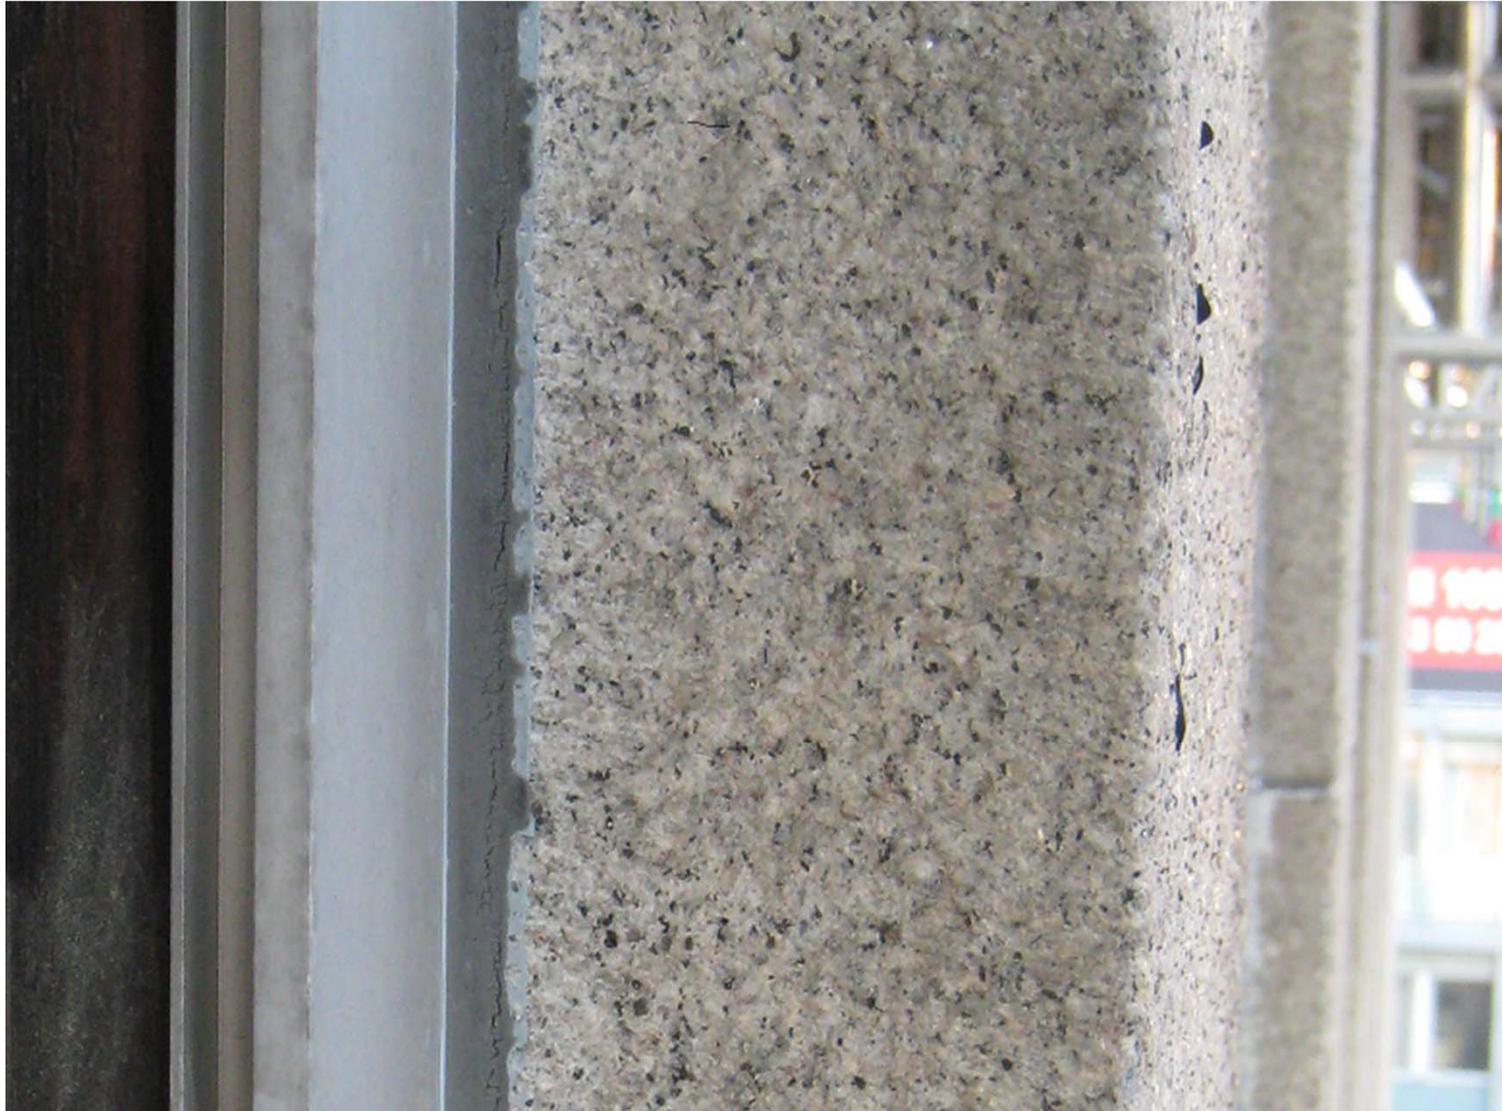
Between window and stone wall

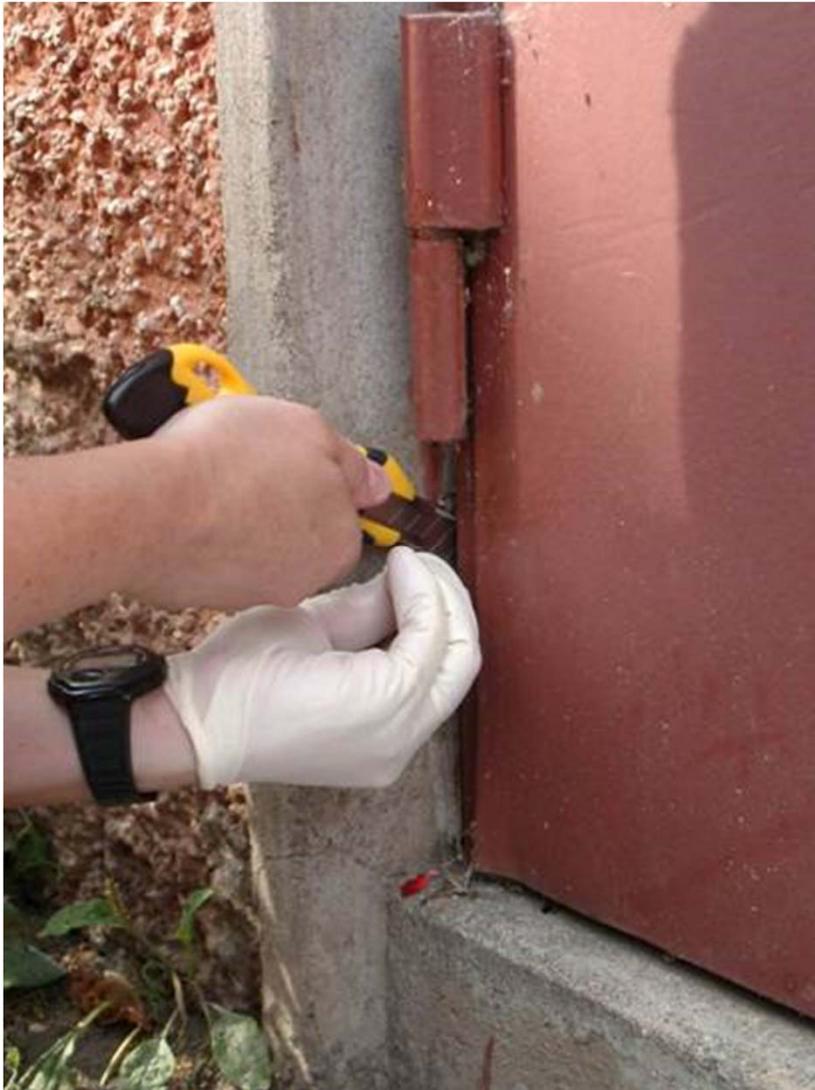
Taking samples

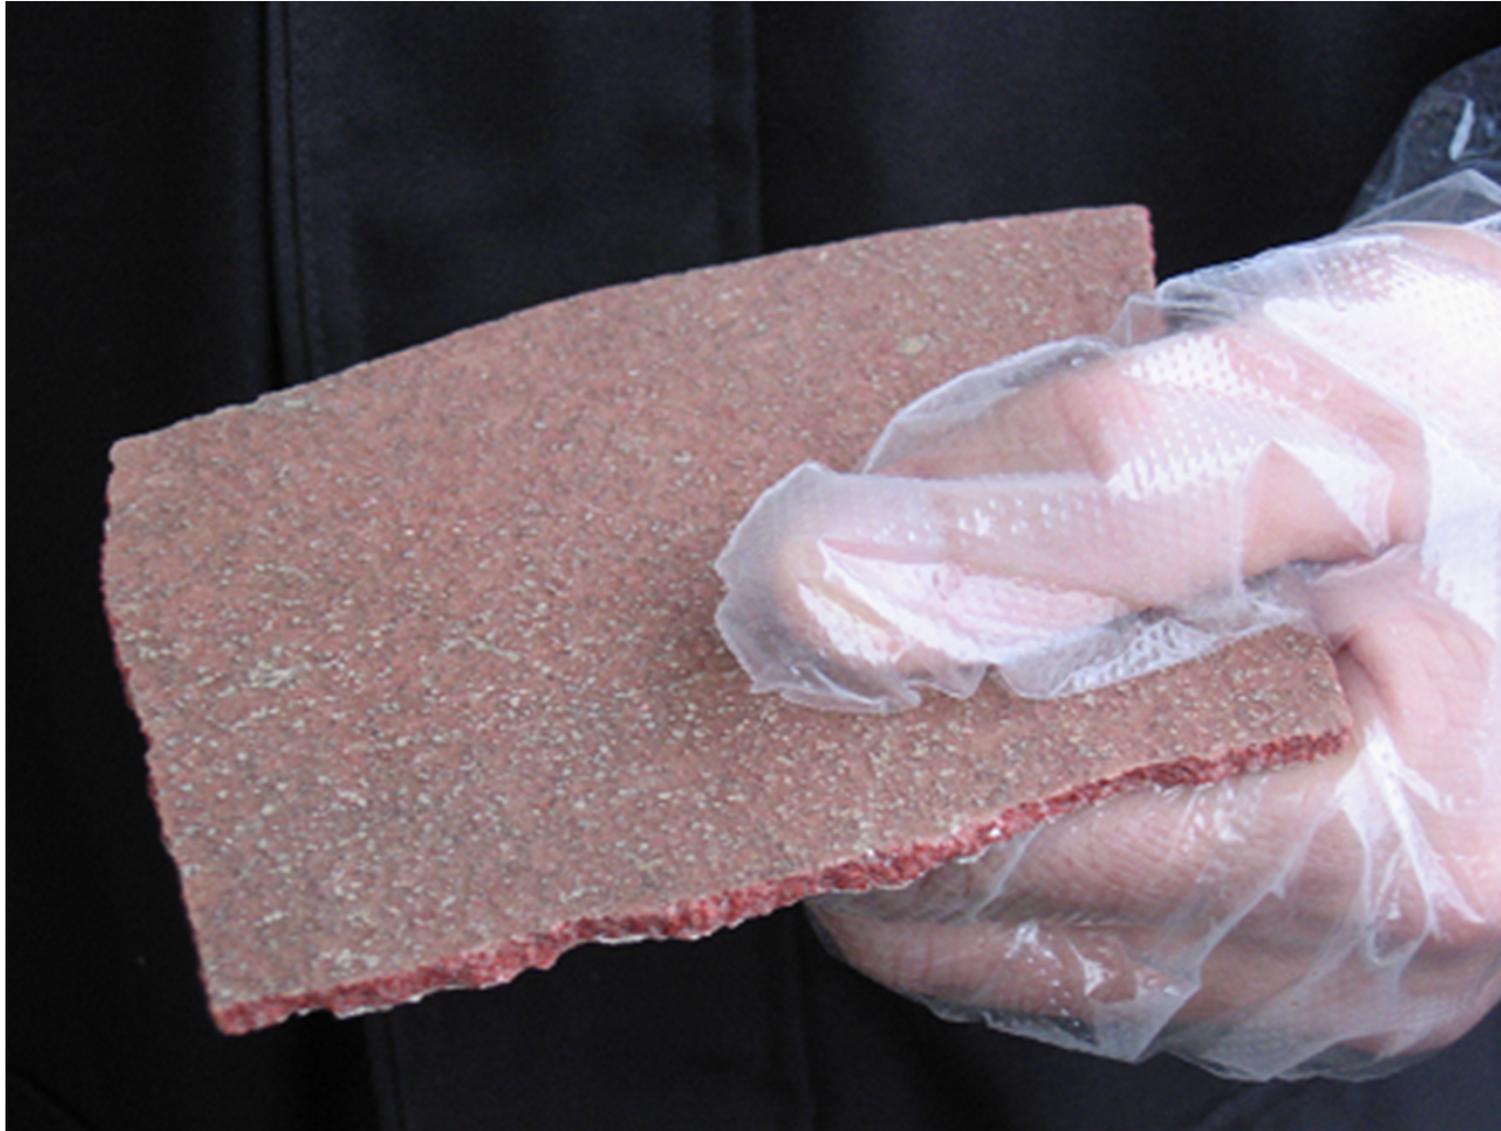
Floor coating

- Sealants in buildings erected or renovated, 1956 – 1973
- Flooring, “Acrydur”, non-slip floor coating used for example in the food industry, 1956 – 1973
- Capacitors in electrical equipment, 1956 – 1980
- Sealants in insulated windows 1956 – 1973
(Swedish production)

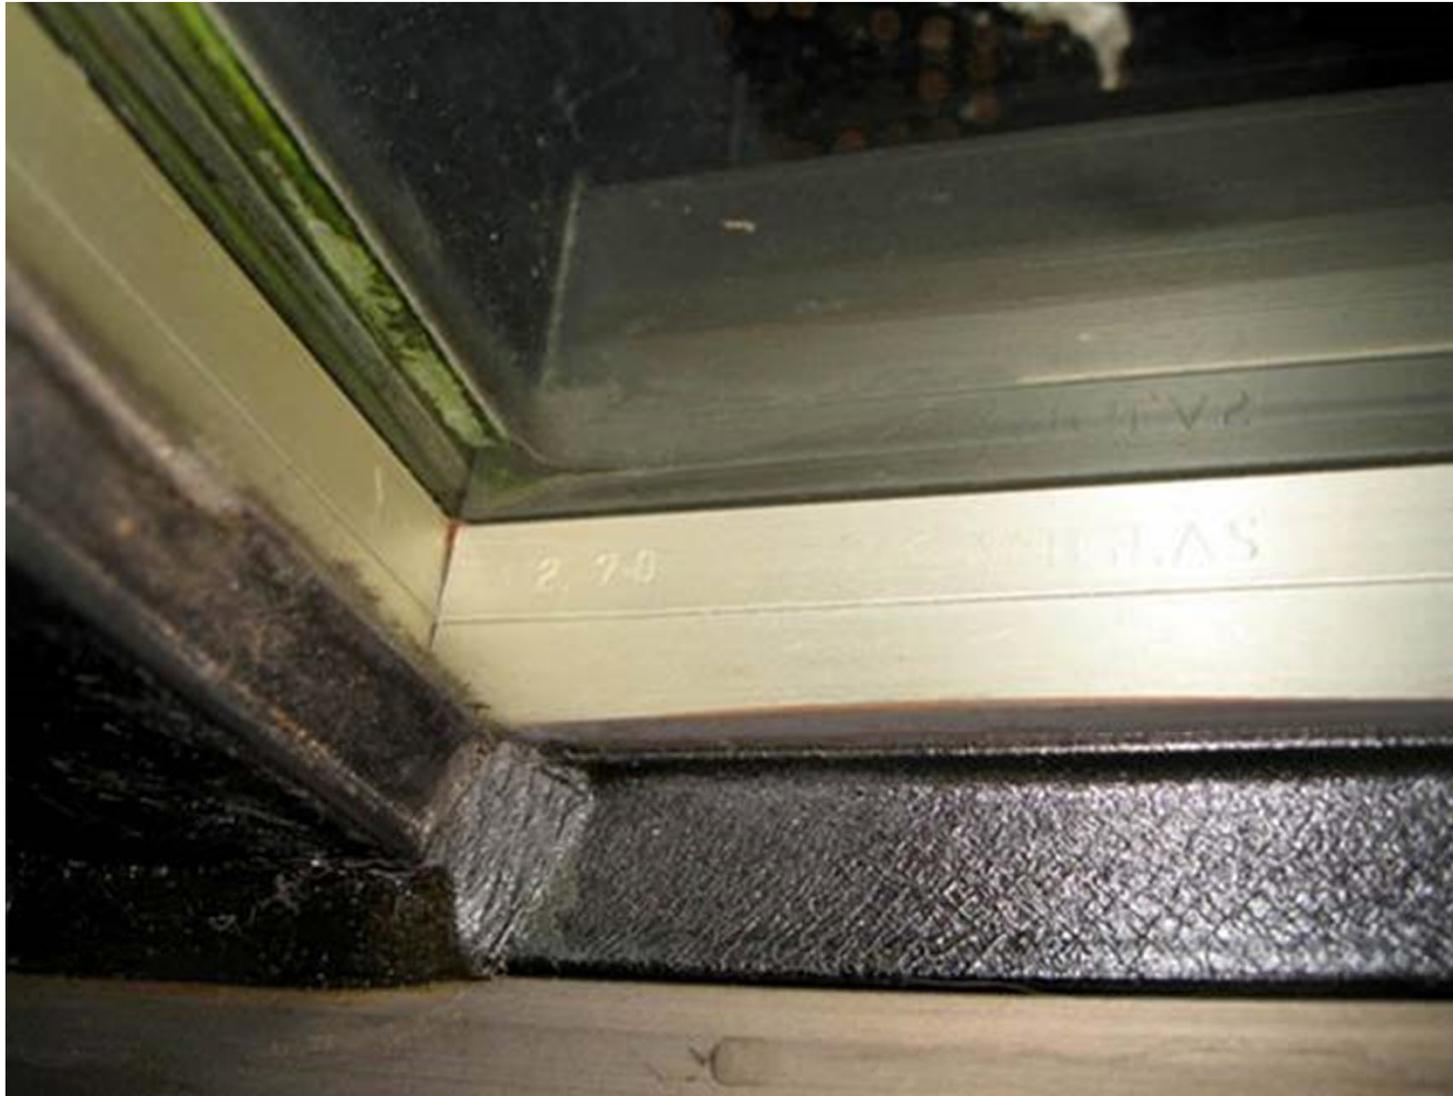
Marking on an insulated window

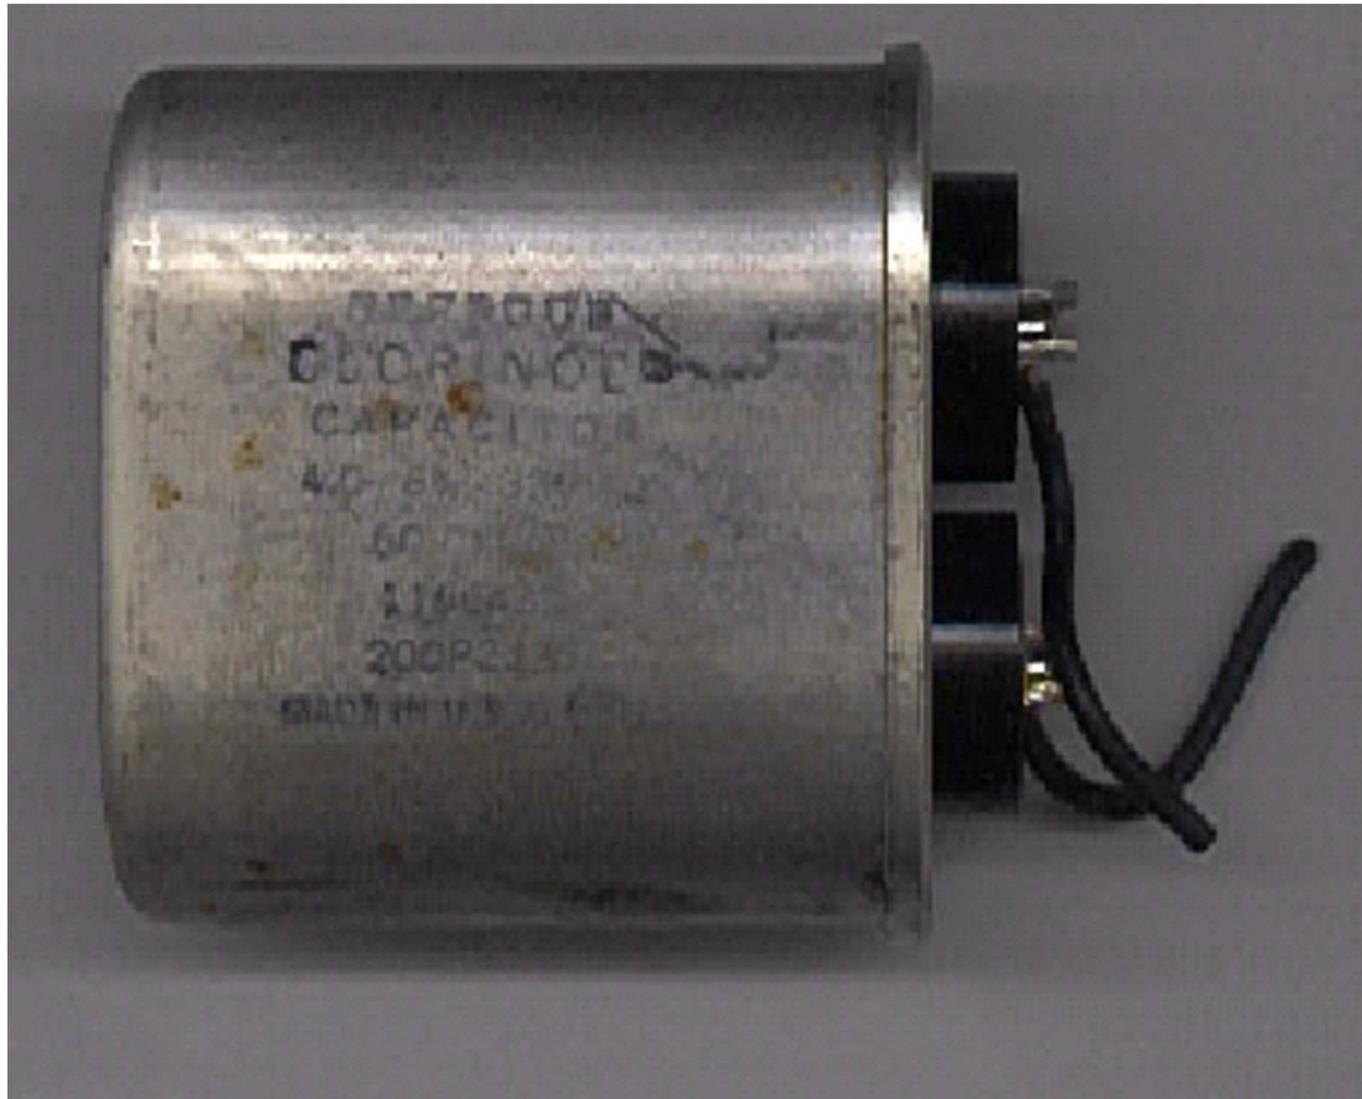
Capacitor with PCB oil

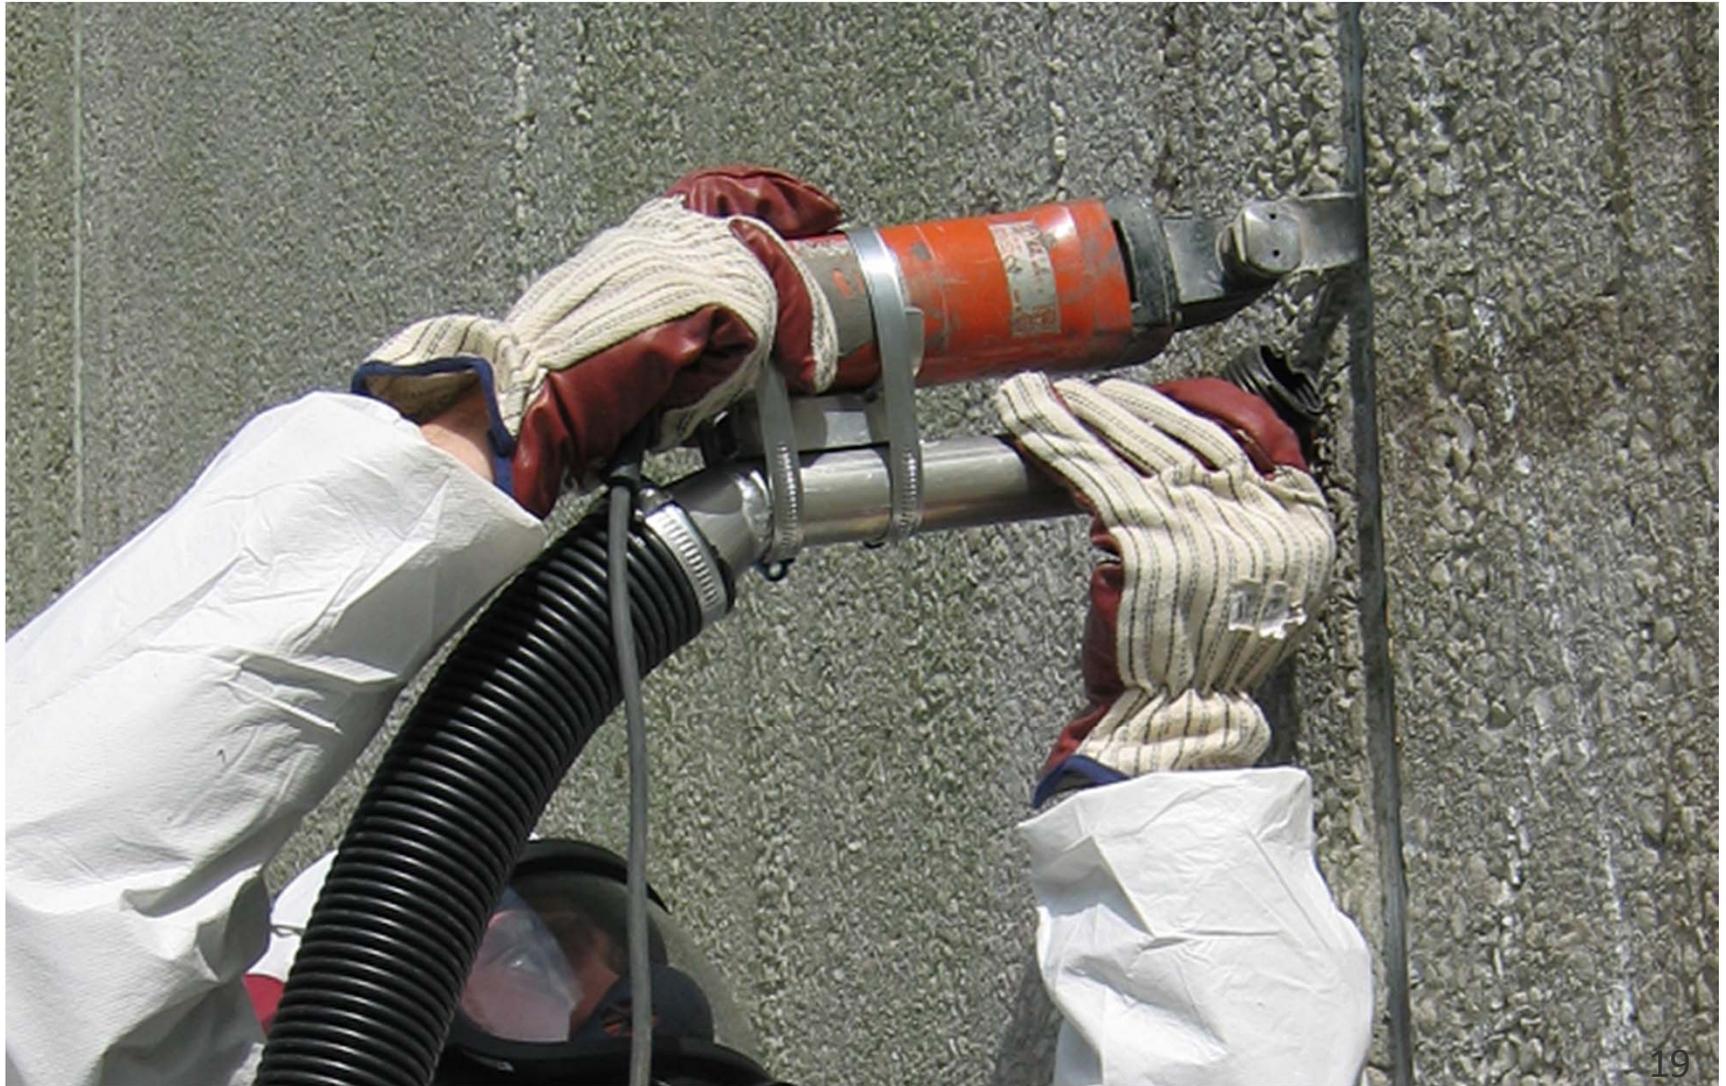
Cutting sealants

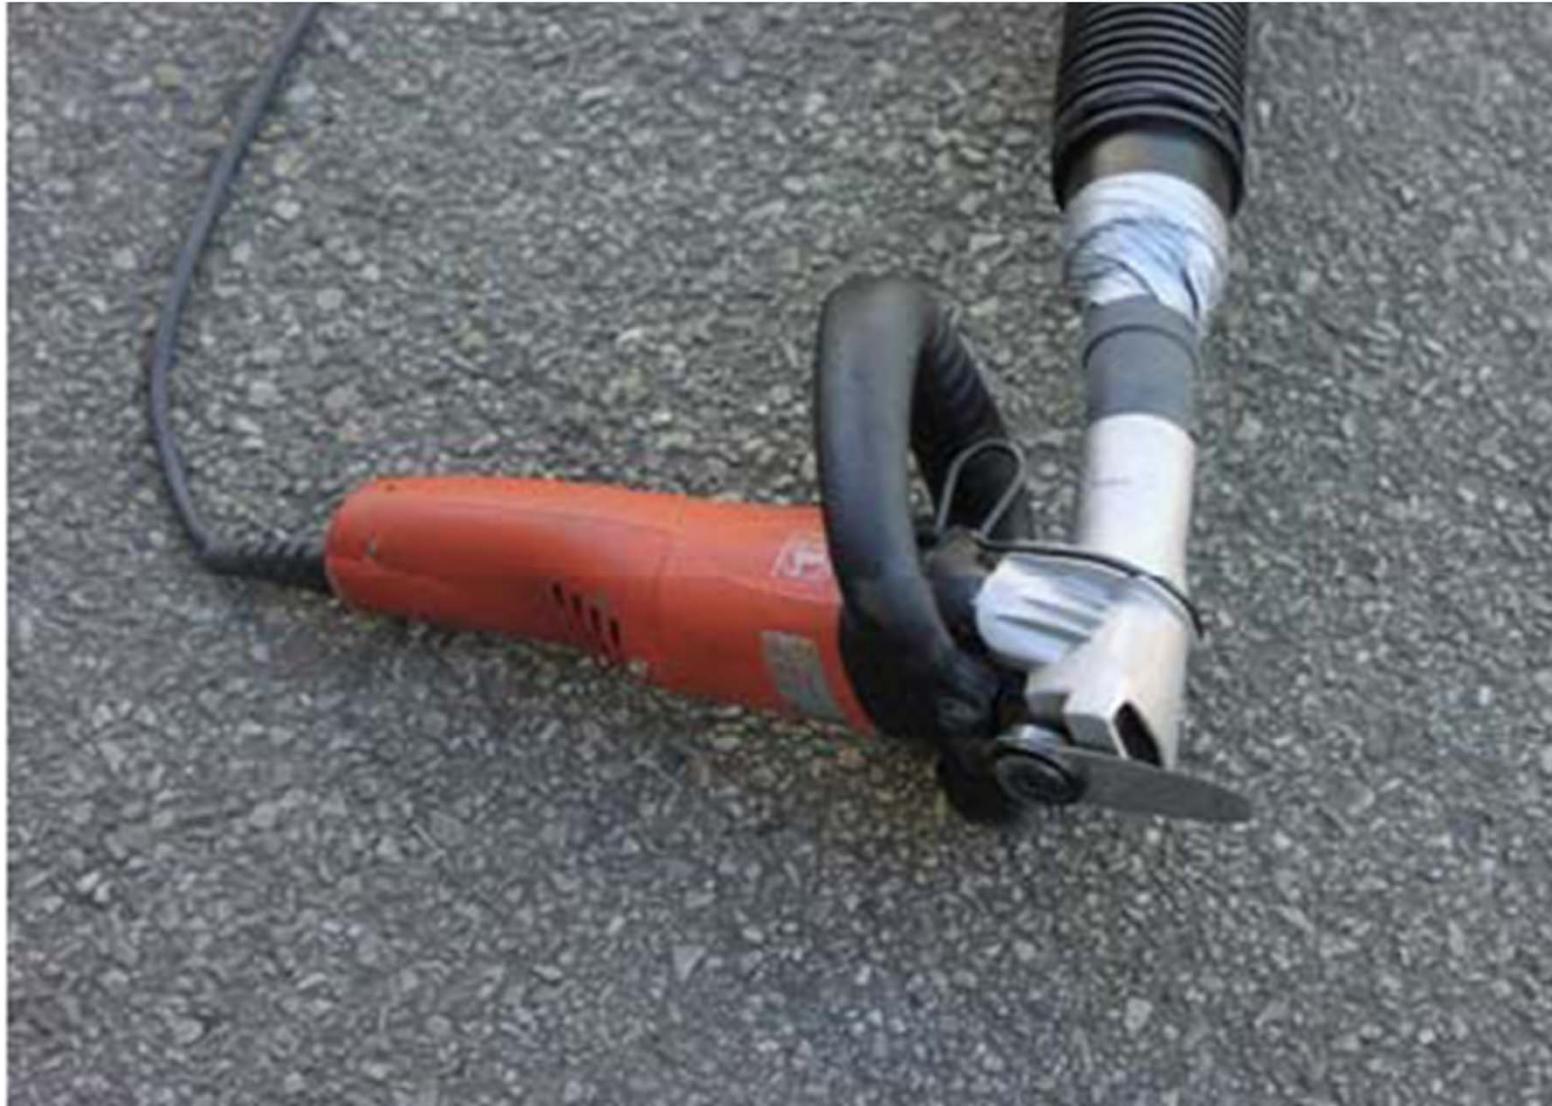
Oscillating knife cutter from Fein

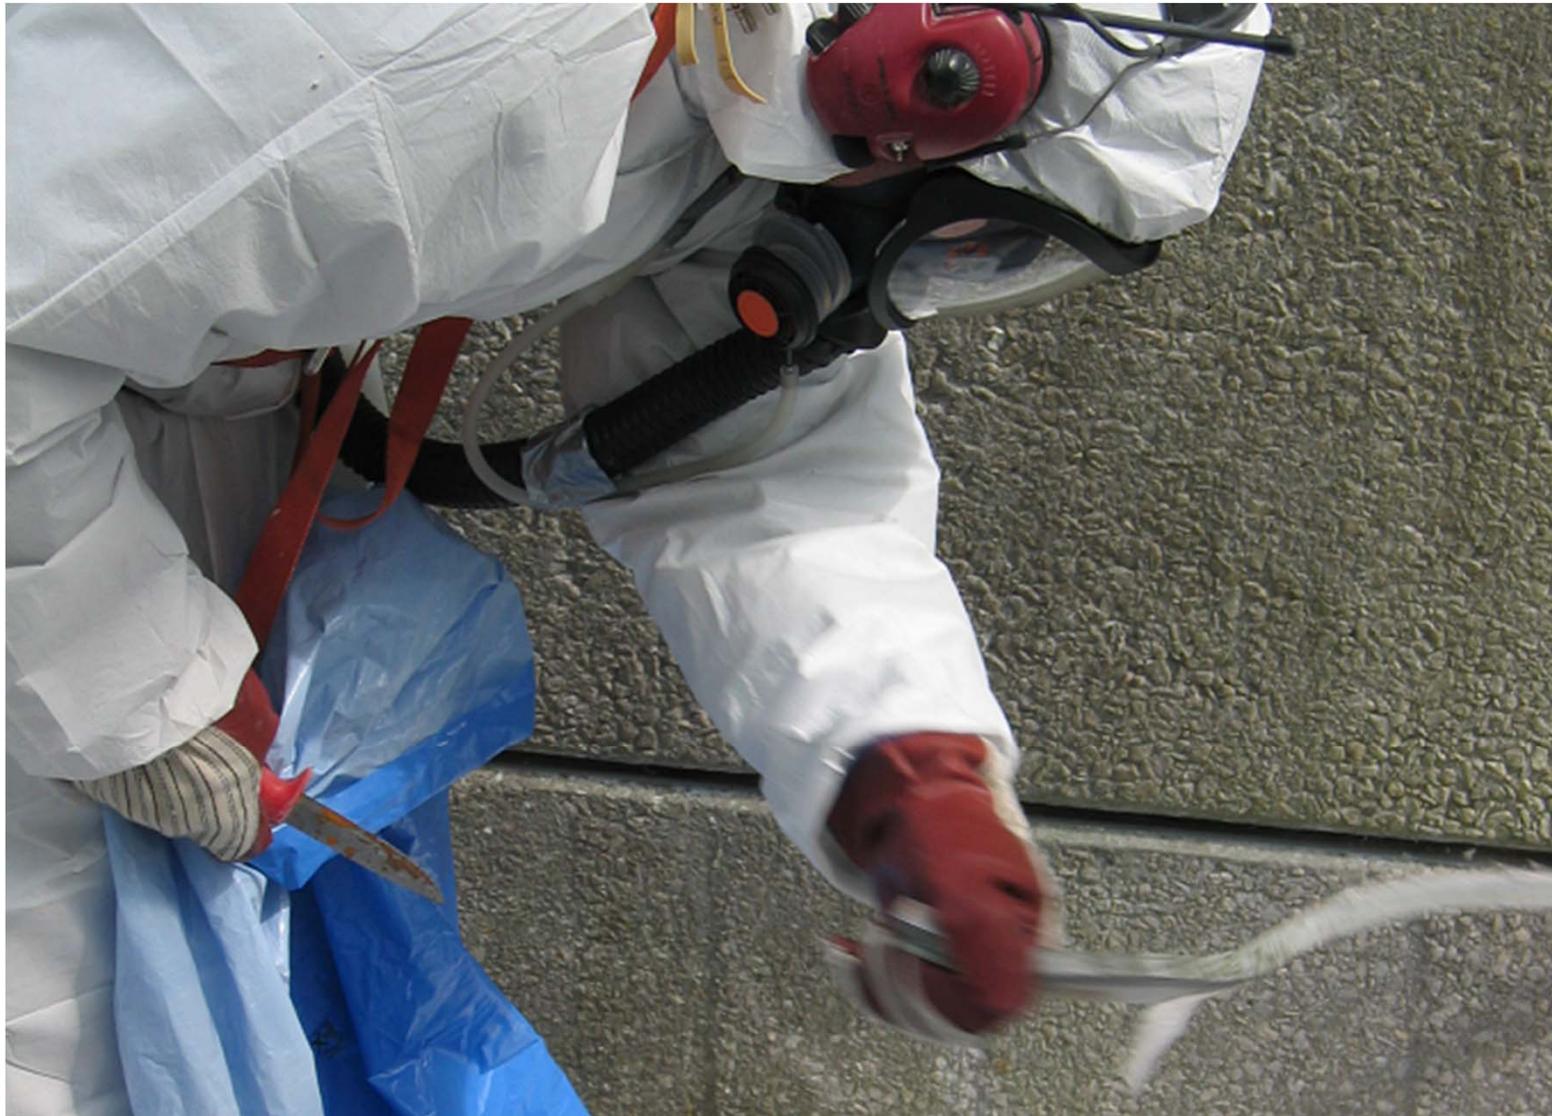
Cutting with an ordinary knife

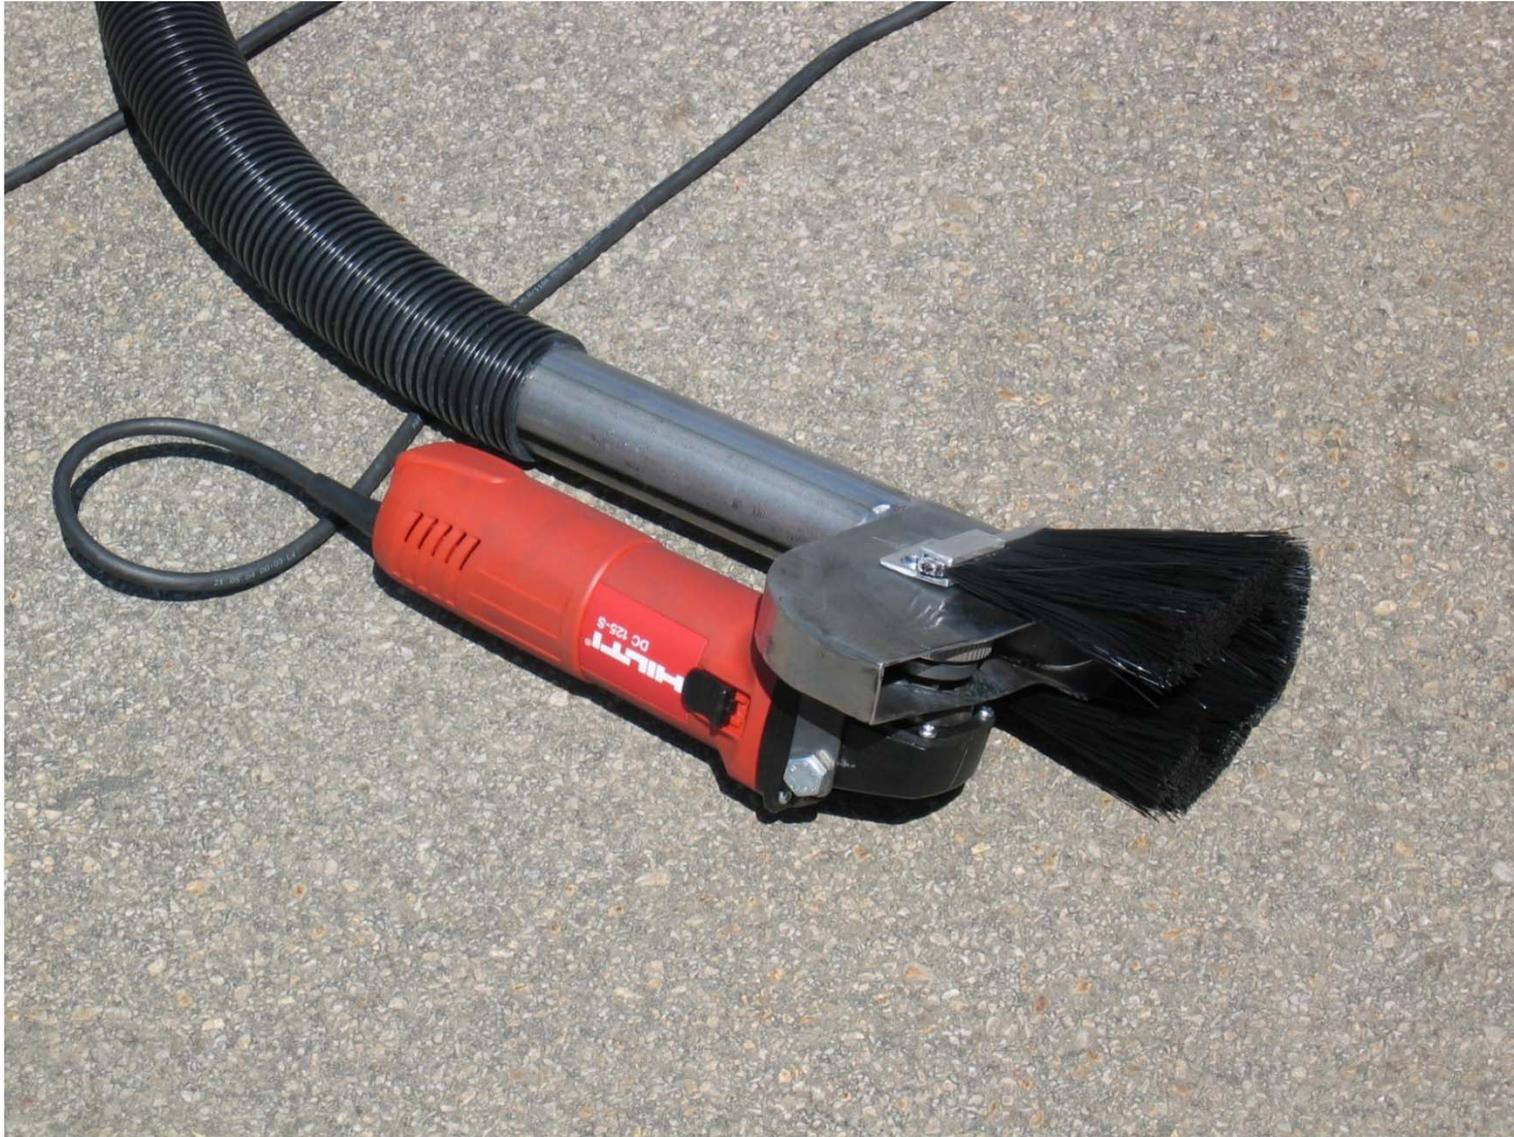
Grinder with a dust-collecting hood

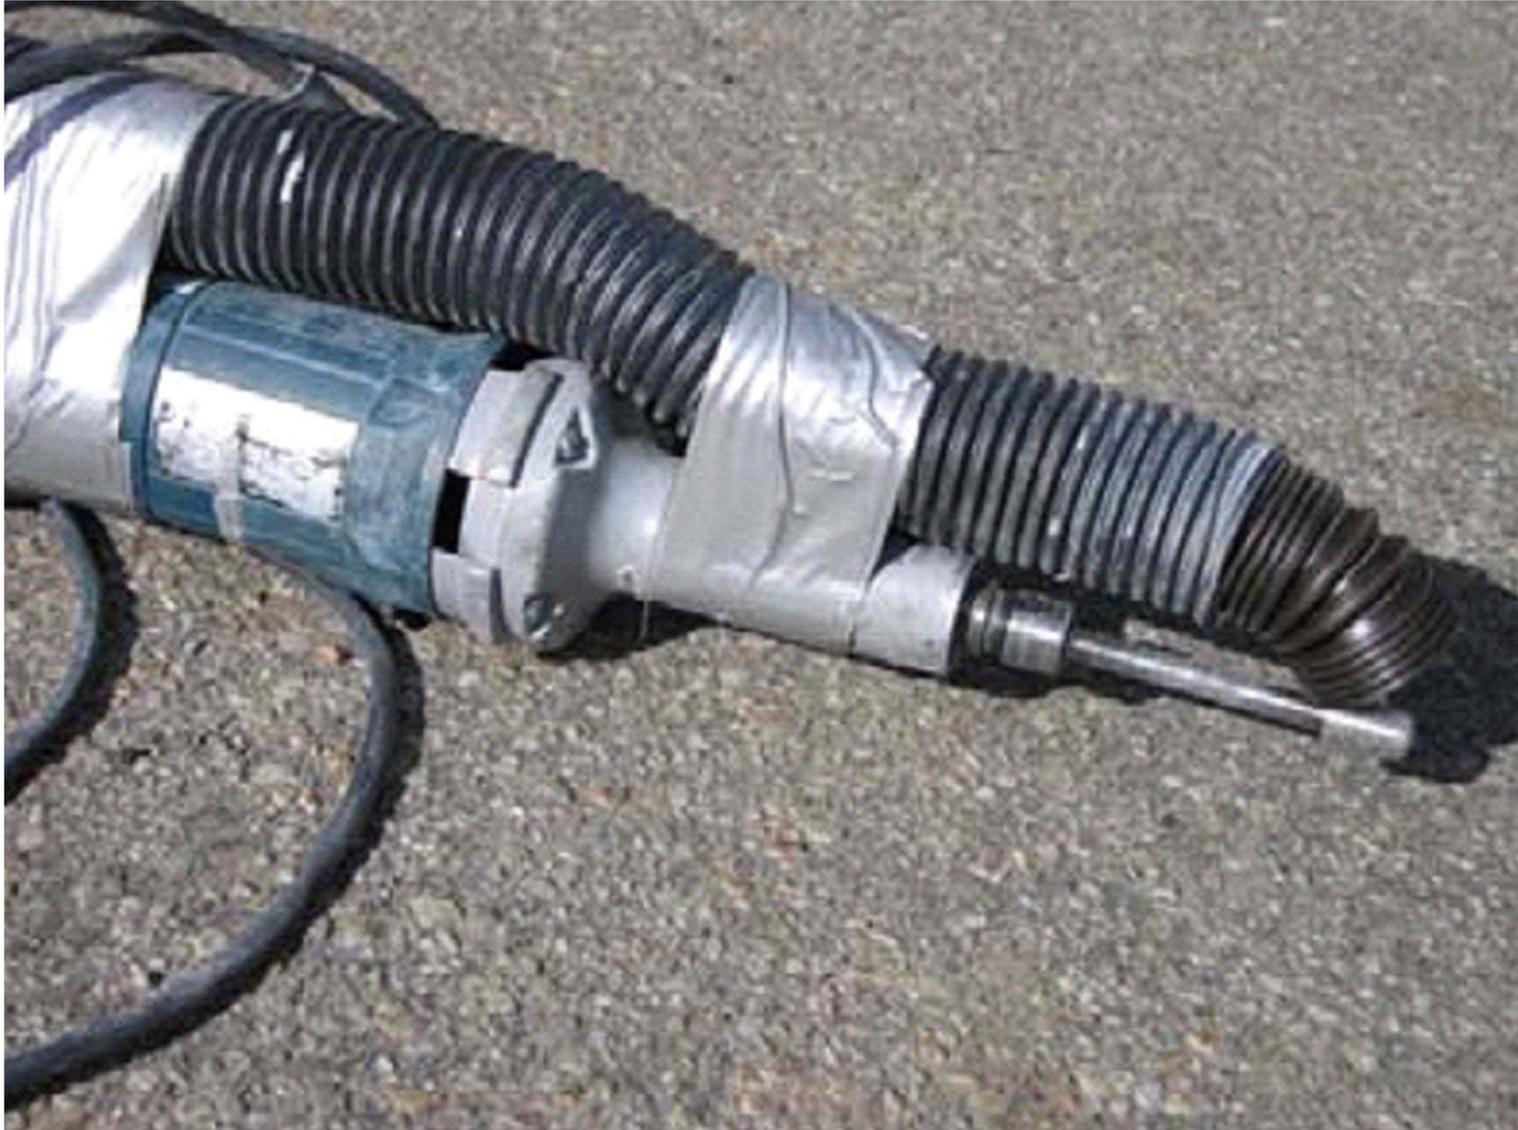
Cylinder grinding pin tool

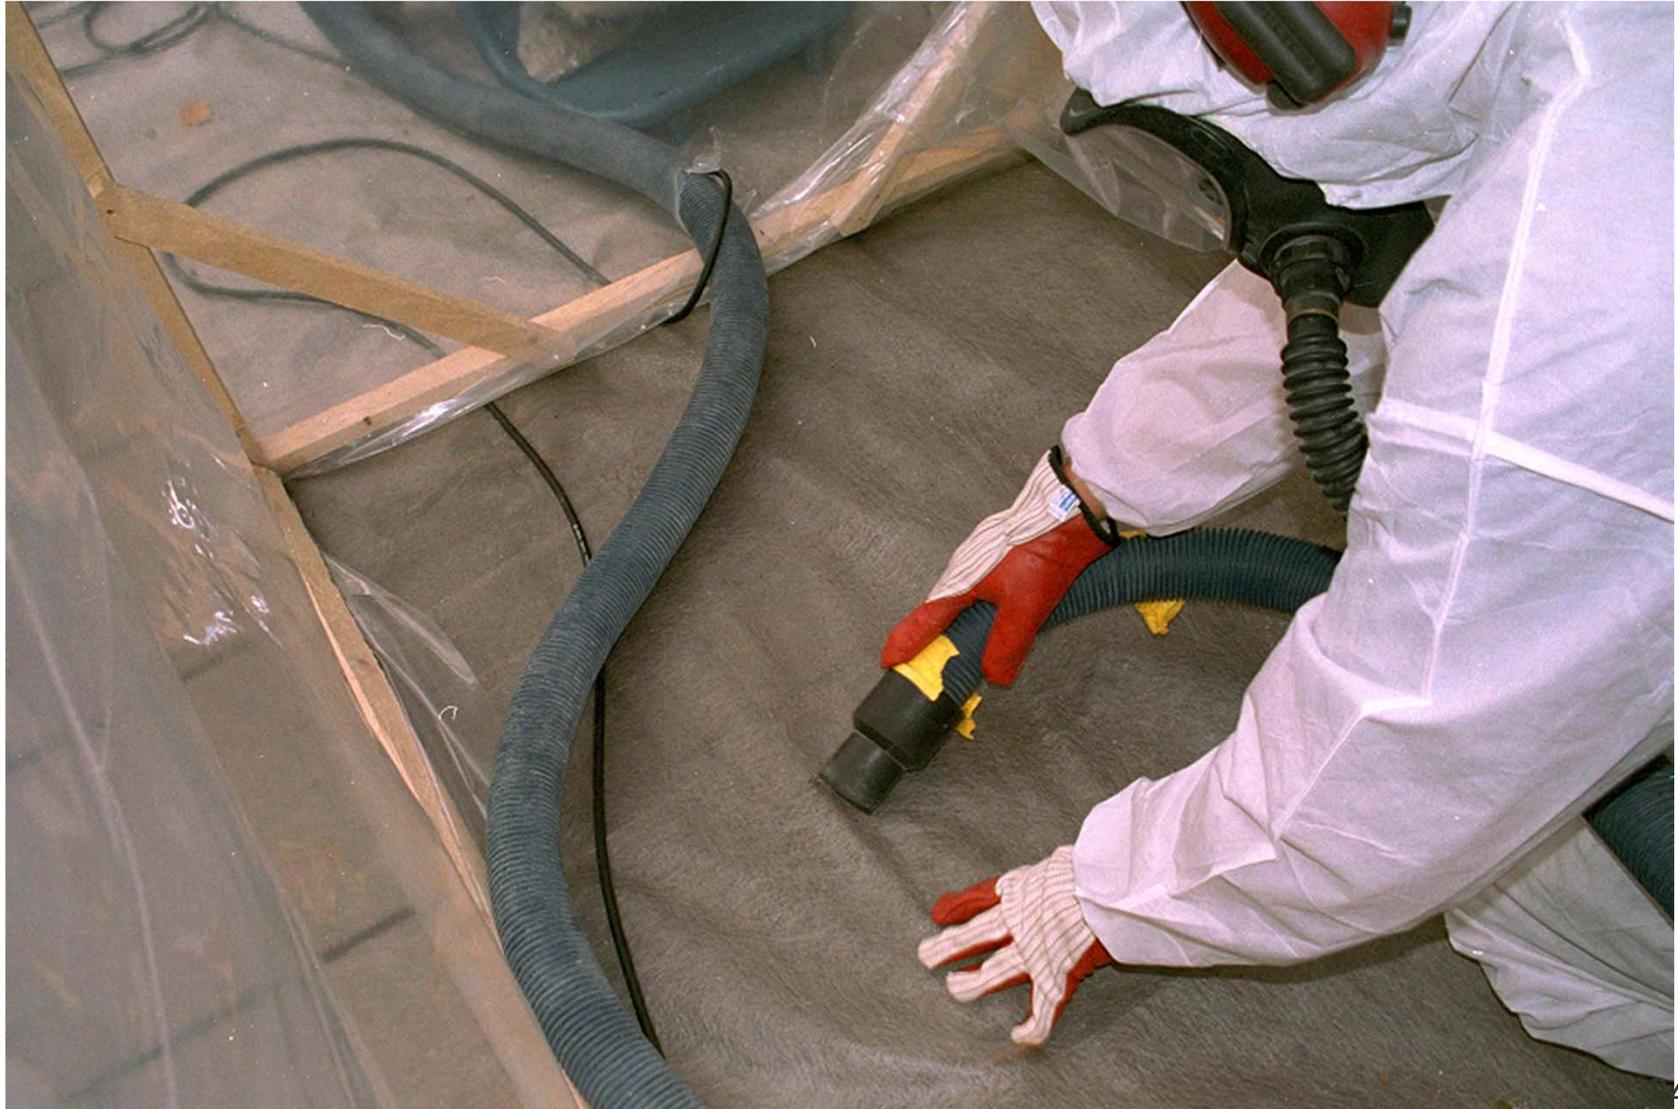
The protective covering is cleaned
