*Identification and
clean up of PCBs in
Sweden*

*Per Lilliehorn
Gunilla Bernevi Rex*

The Swedish Approach

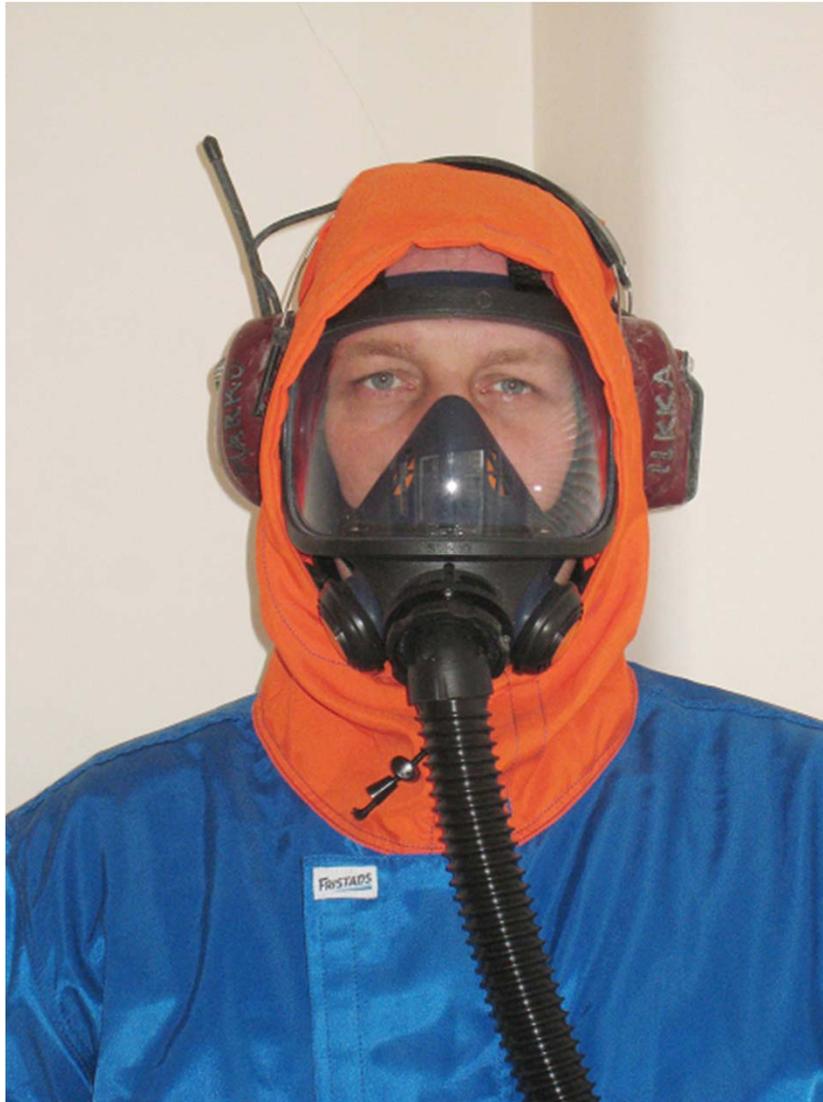
Protective equipment

- Protective mask with
 - Forced air supply
 - Particle filter
 - Gas filter
- Overall
- Gloves
- Ear protection

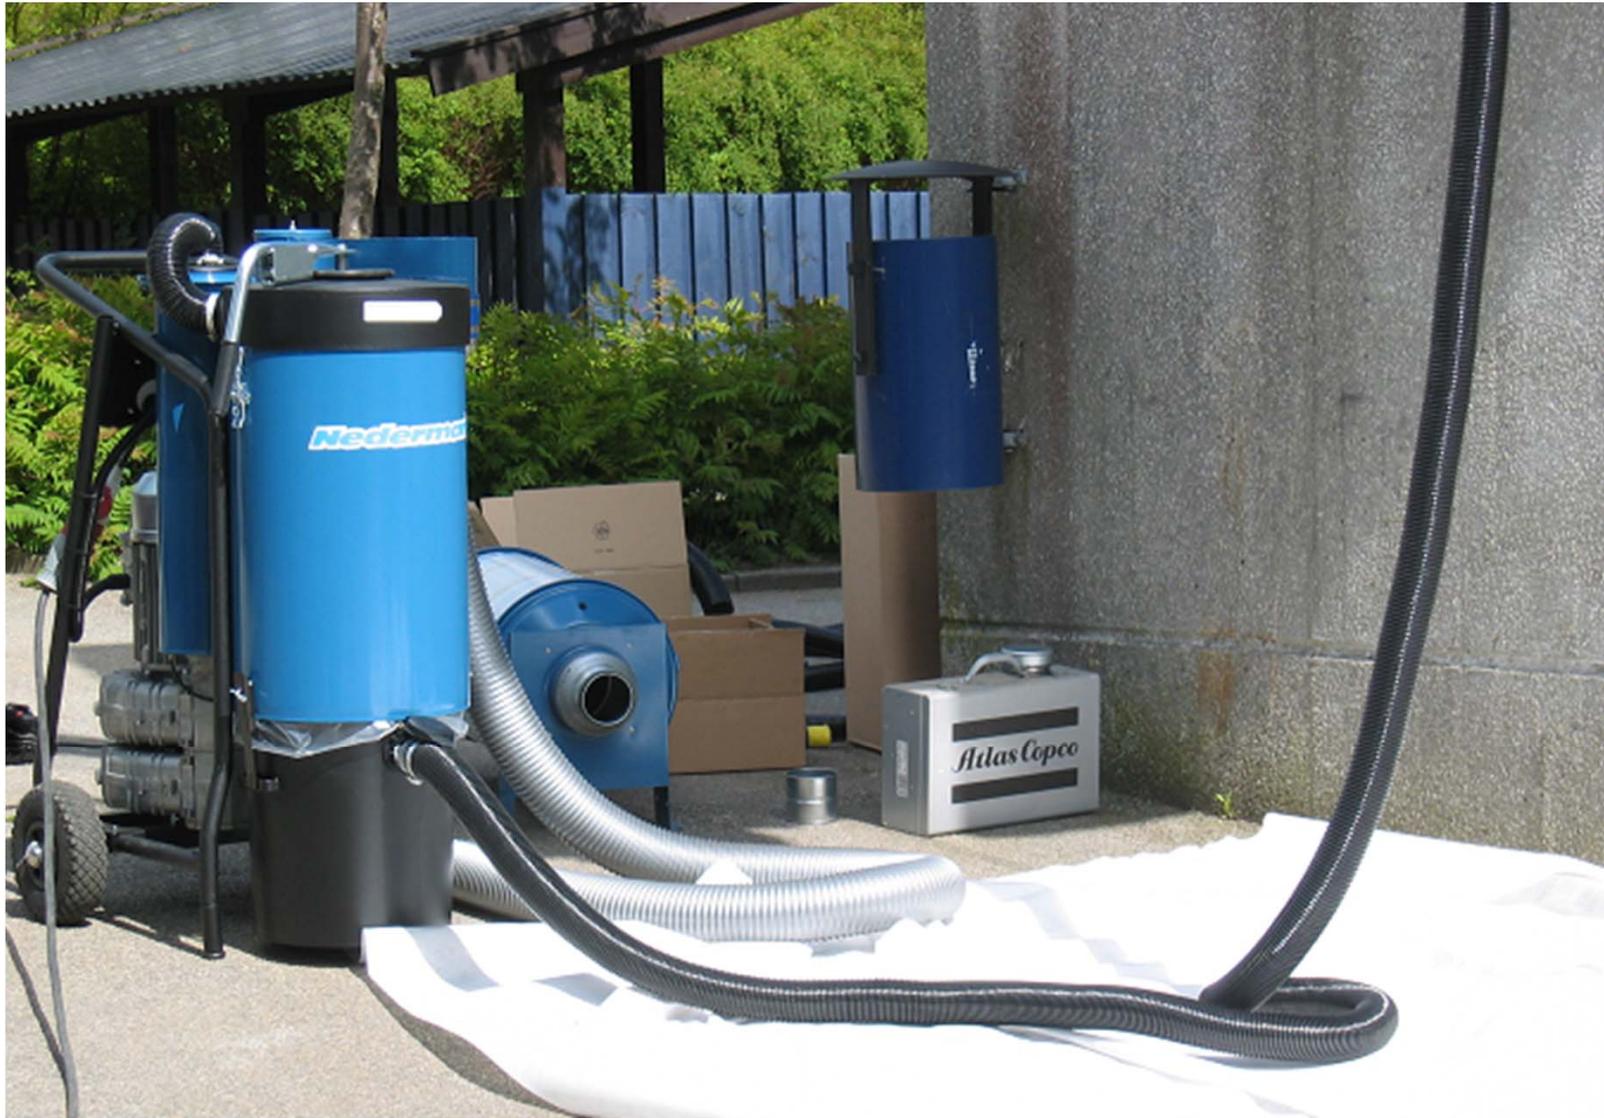
Powerful vacuum cleaner
